GEOLOGICAL INVESTIGATION & LANDSLIDE RISK ASSESSMENT OF A SECTION NEAR KHARPADA VILLAGE ALONG MUMBAI-GOIA HIGHWAY

Submitted in partial fulfilment of the requirements

Bachelor of Engineering

Anjuman-I-slam's Kalsekar Technical Campus

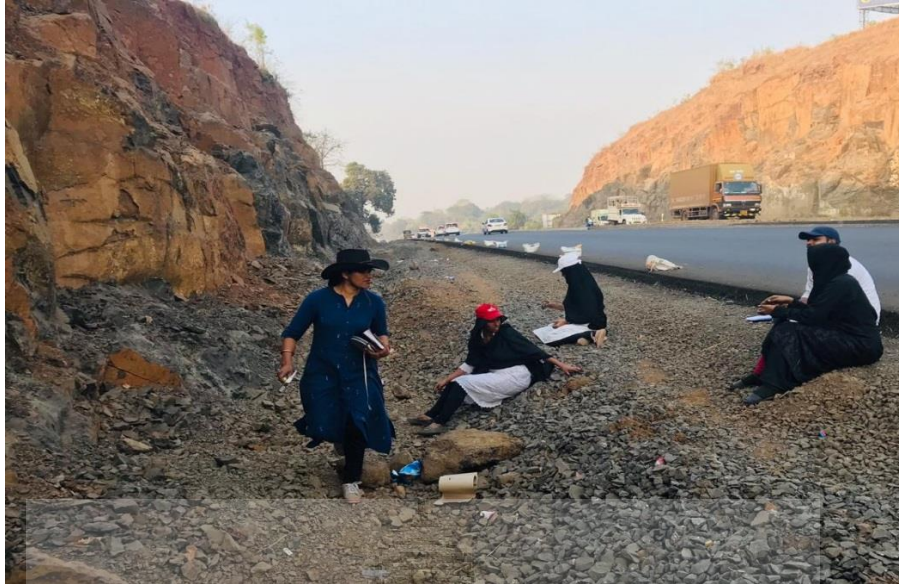
The lithounits present in the study area are completely aphanitic basalt. These are compact basalts with no gas cavities all along the exposure. The compact basalt of the study area show thick flows with nearly flat top. The rock is altered by weathering giving rock a brown to red colour due to iron oxide mainly along the joints. (Fig. 3.1) Fresh unaltered Basalt showing bluish grey colour is present at the core of jointed blocks and at places where openness of joints is negligible.

Fig. 3.1 Compact Basalt exposed in the study area is altered by weathering along the joints

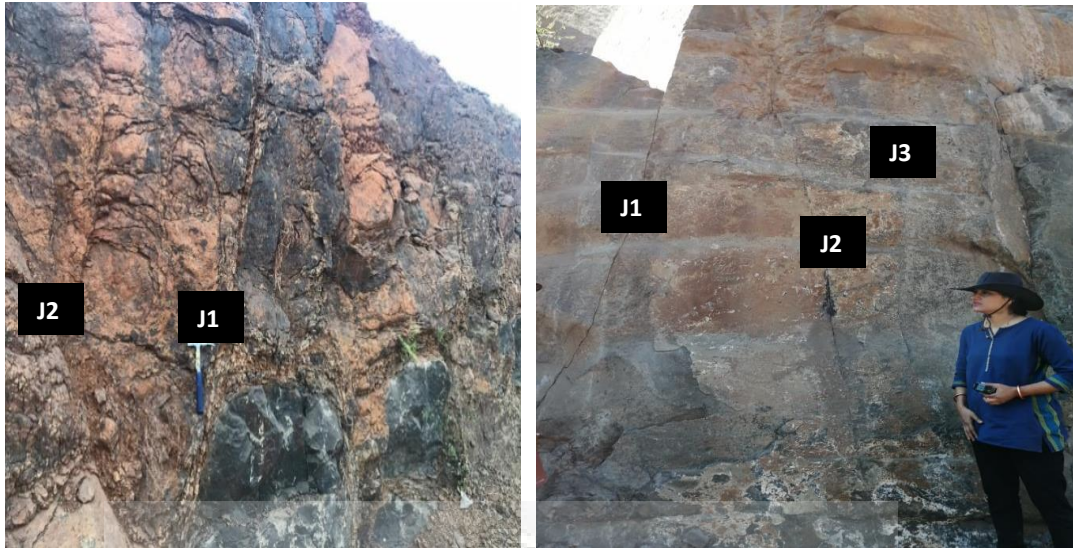
The first step is the identification of set of discontinuities present in the area. A set of parallel joints of common origin is called a joint set. A few joint sets may often intersect forming characteristic patterns. They may intersect perpendicularly or obliquely creating joint systems. Presence of joint systems or joint sets gives a fragmental appearance when they are closely spaced and a blocky appearance when widely spaced. In the present study 3 set of joints J1, J2 and J3 have been identified, where J1 and J2 are near vertical and J3 is horizontal (Fig. 3.2). These joint set divide the rock into blocks of varying size as solutions moving along joints separate the blocks from the intact rock. The joint set J3 has developed in only upper part of the

Fig. 3.2 Three set of joints J1, J2 and J3 in the study area

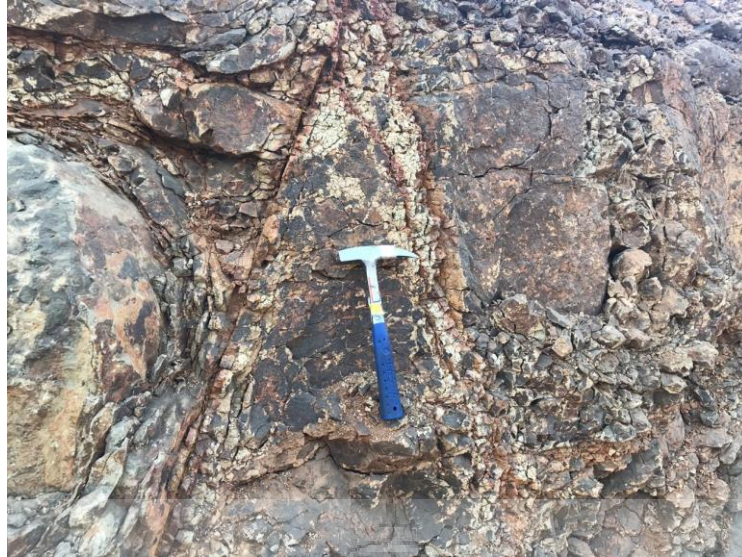
The pole diagram of this set of joints is showing two clusters on opposite quadrants as some joints dip steeply NW and some steeply SE(Fig. 3.4a). The second set of joint is also steeply dipping (70° - 88°) with a strike NW-SE.

Fig. 3.3 Joint set J1 trending NE-SW and J2 trending NW-SE

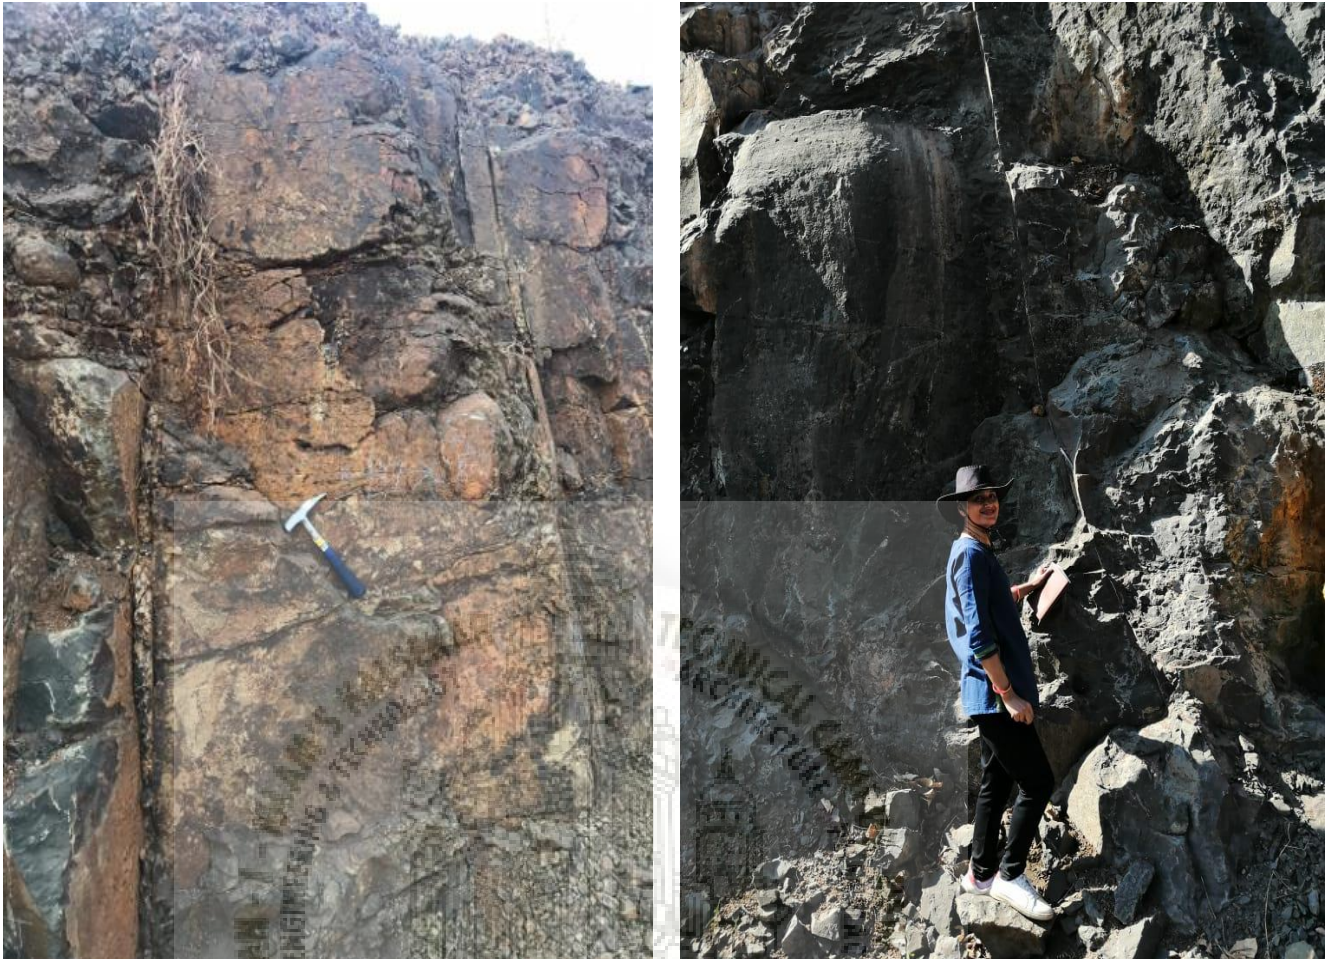
The joints J1 and J2 it is continuous throughout the exposure and may be continued beneath the surface up to some depth and hence can be classified under the category C3 (10 to 30 ft). However joint set J3 is discontinuous. The continuity of the joint surface is in the direction of dip for J1 and J2 and in the direction of strike for joint set J3. Both ends of the joint can not be observed (Fig.3.7) on the exposure for joint set J1 and J2 and hence it is in category E2 according to the table 3.5 (Goodman 1976)

Fig. 3.7 Field photograph showing continuity of joint

The persistence of the joints is very high, and both the ends of the joints do not terminate in the exposure (Fig. 3.7). This may be an unfavourable condition but except from spot no 1-7 and 17-18 the openness is negligible due to which water can not percolate through joints and cause weathering. The effect of weathering due to joints can be clearly seen in the varying grade of weathering in the left hand side and right hand side rock formation (Fig. 3.9 a&b). Along the right hand side section the joints are closely spaced and Joint set J3 is more developed in the upper part, the rock is highly weathered and showing spheroidal weathering at the spot no 1-7 (Fig. 3.14) The right block show the filling of joints by weathered material whereas the left block show thin film of quartz. This compositional variation itself is making the left block more stable. The moisture is more in the open joints in the right hand side sequence which is clear from seepage of water and presence of vegetation whereas the left hand side sequence is completely dry. The Schmidt Hammer test clearly show high compressive strength for the solid rock mass whereas the strengths is greatly reduced in the areas affected by weathering in the vicinity of joints (Fig. 3.13).

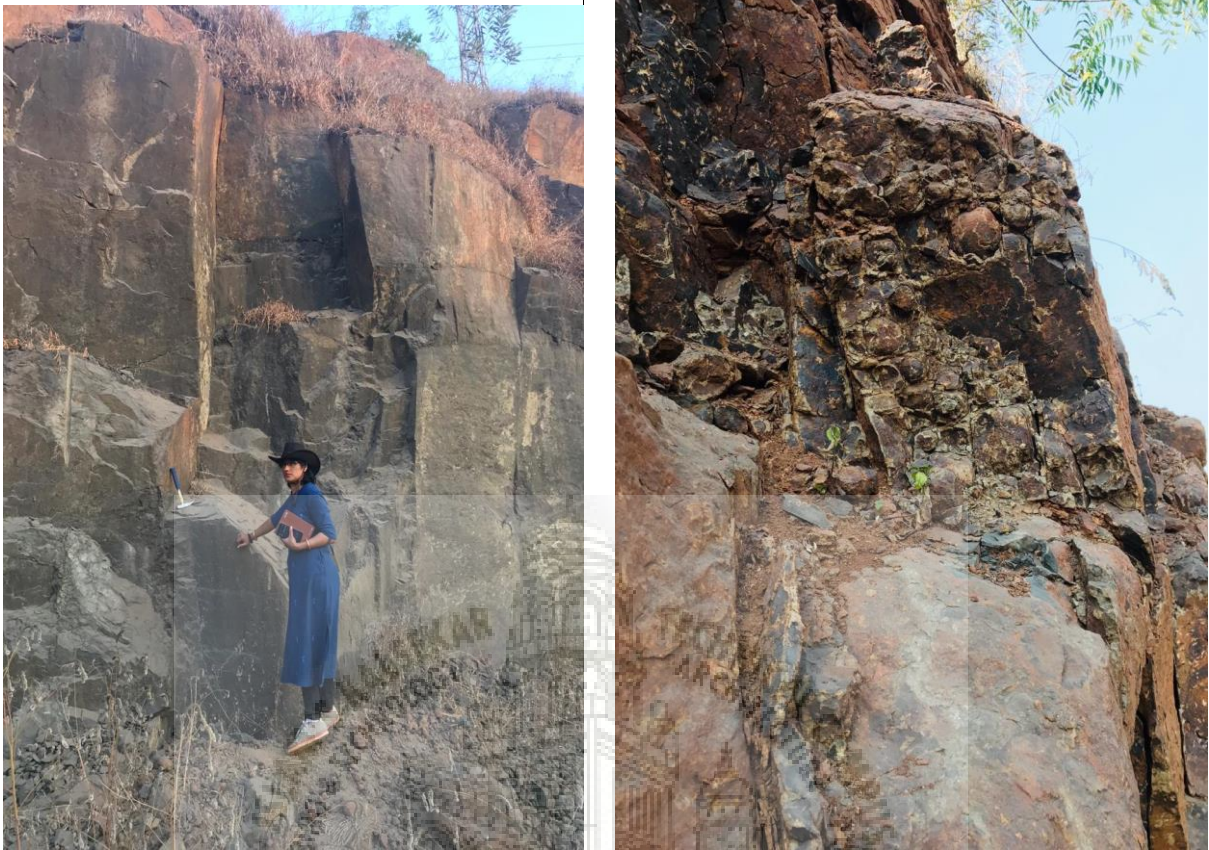
The openness is measured normal to the fracture surface. This aperture or openness affects the strength, deformability, and seepage characteristics. The descriptor for the openness is given in the table 3.6 (Goodman 1976) Joint set J1 and J2 do not show any visible separation (NVS) from spot no 8-16 (Fig. 3.8a) J1, J2 and J3 are moderately to wide open at spot no. 1-7 and spot no 17 (Fig. 3.8b). The horizontal joint set has developed only in the upper part of the section on the right hand side of the road (spot no. 1-7 & 17-20) and falls in the open category (3 to 10 mm) table 3.7

Fig. 3.8(a) Joint sets show negligible openness

Fig. 3.8(b) Widely open joints at spot no 6

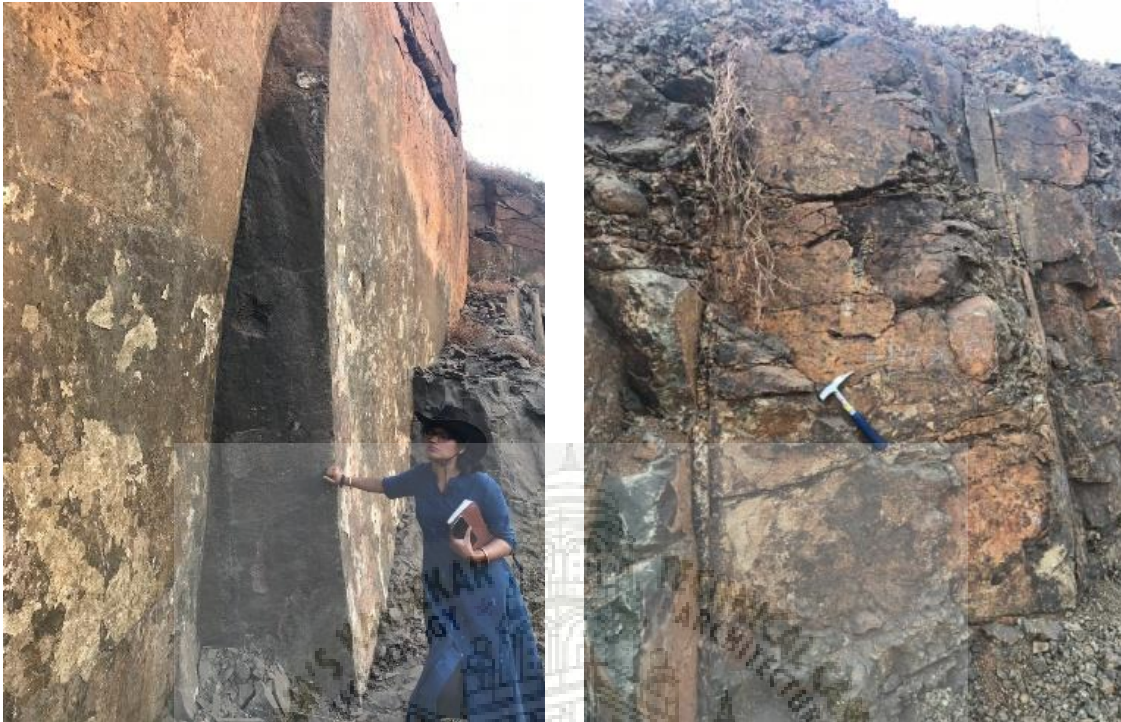
The mineralogical classification of fillings is important to convey the physical properties of fractures that may be significant criteria for design. The present study shows that the joints from spot no 10-17 show quartz filling (Fig. 3.9.(a)) while other joints show filling by weathered material mainly the oxidized product form by weathering of iron bearing minerals in Basalt (Fig. 3.9.(b)). Clay is also present in small amount as it is clear from the vegetation along the

fractures, the clay may swell or cause swelling pressures and cause more opening of joints.

Fig. 3.9.(a) Field photograph showing thin layer of quartz along joints

Fig. 3.9.(b) Field photograph showing weathered material along joints

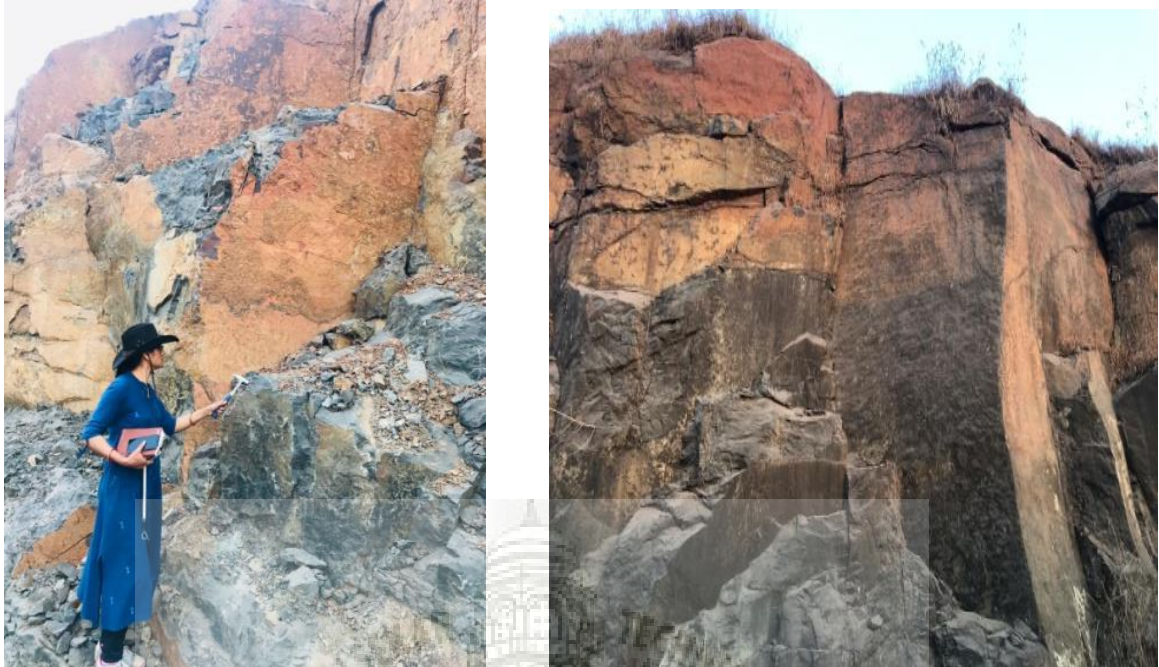
Most of the joints wherever the openness is open (O3) to wide (O5) are showing varying degree of alteration and weathering. The iron-rich minerals in Basalt have oxidised to give brown to red colour staining to the rock due to formation of iron oxide (Fig.3.10a) The joint set from spot no 10-17 are showing no staining in the lower part as there is negligible openness along the joints (Fig.3.10b).

Fig. 3.10 Field photograph showing Weathering/Alteration along Joints

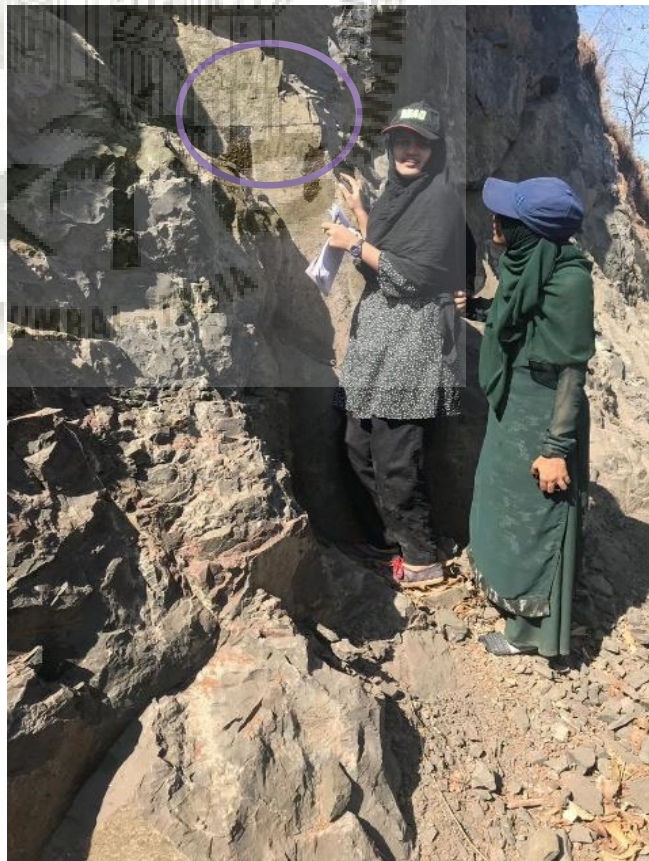
The joint surface is generally dry but shows evidence of water flow such as staining, leaching, and vegetation. Some of the joint surfaces show seepage and is wet with occasional drops of water(Fig.3.11).

Fig. 3.11 Flow of water along the joint

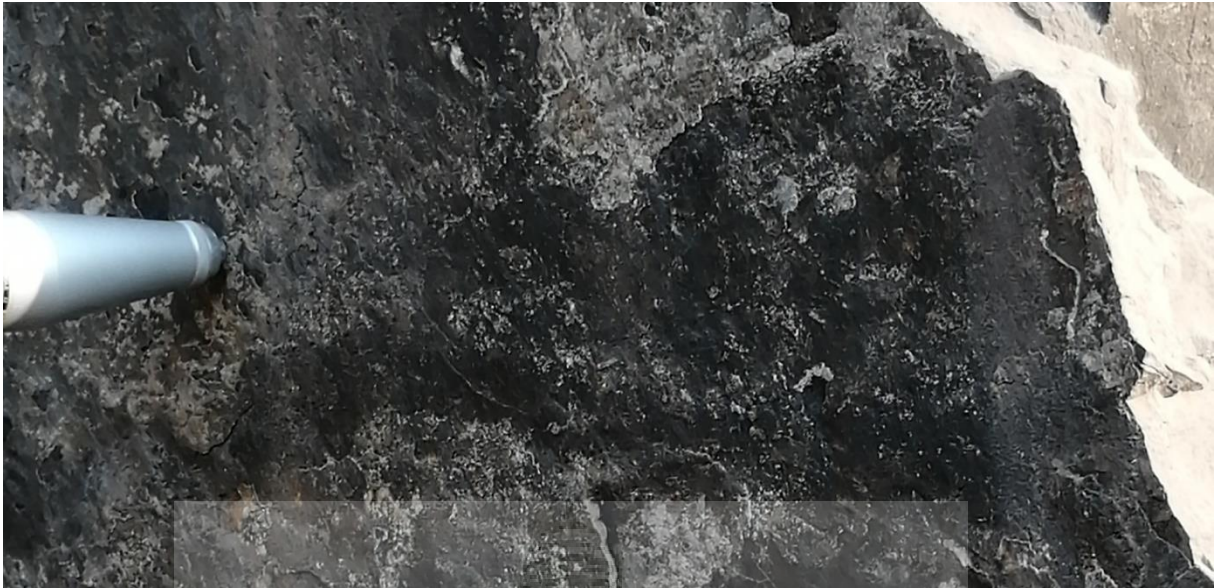
Schmidt Hammer tests can be used to estimate the hardness/strength of the rock surfaces along a discontinuity by orienting the hammer perpendicular to the surface. Direct testing on rock was done and the reading measured from both the weathered and fresh surfaces (Fig.3.12). Five readings were taken at various locations on each surface. The two lowest values discarded and the remaining three values averaged to get the rebound number. It is clear from the (Fig.3.13) that the compressive strength is very high for the un weathered rock mass whereas it is greatly reduced along the weathered and fractures surfaces.

Fig. 3.12 Schmidt Hammer tests at the field

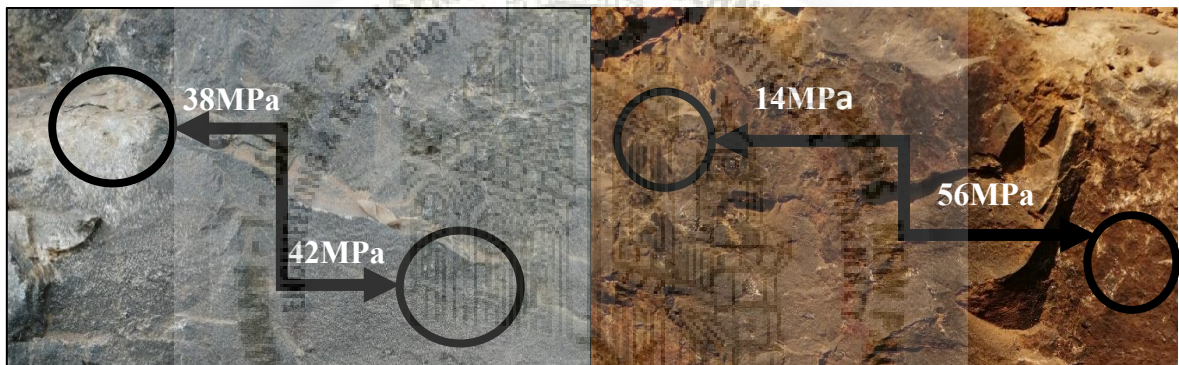
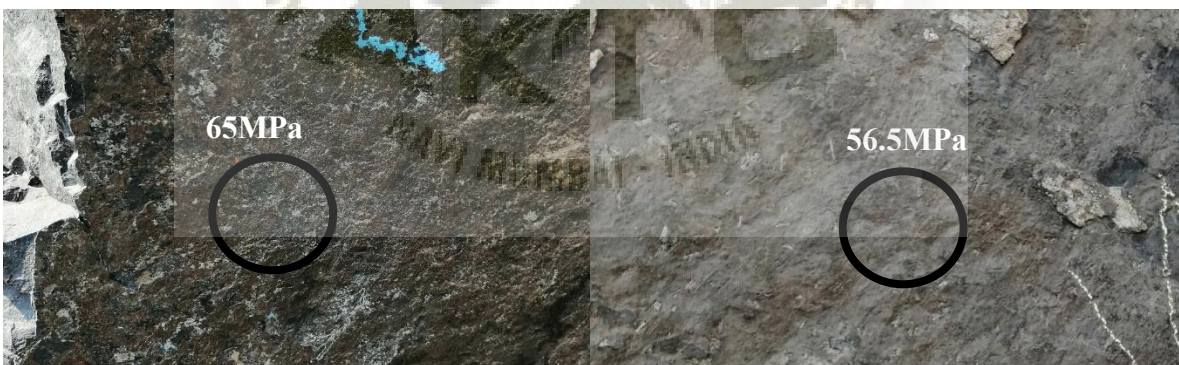
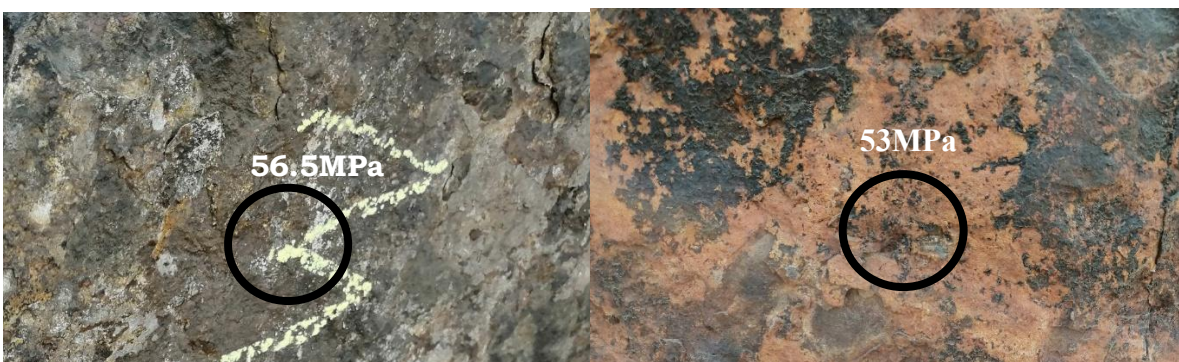
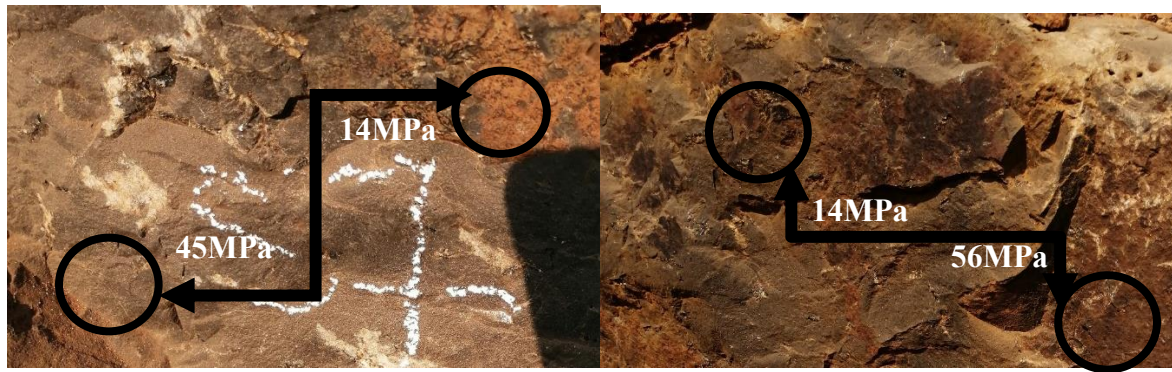
Fig. 3.13 UCS at different locations in the field

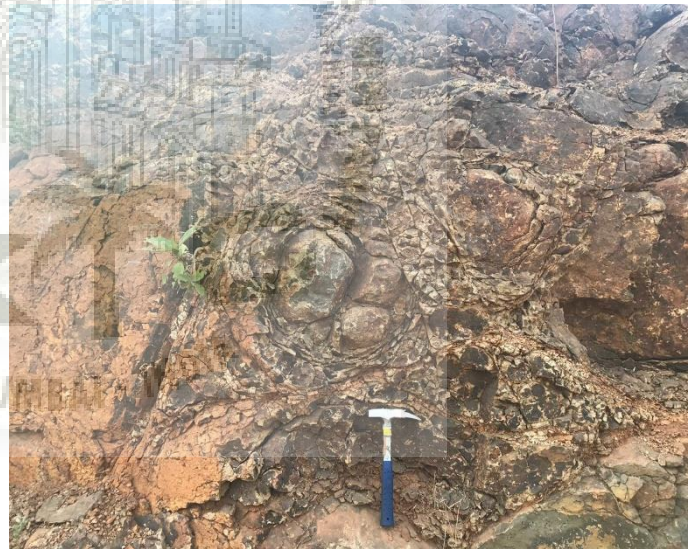
Basalt is prone to weathering due to iron rich minerals which oxidize rapidly in water and air staining the rock in rust colour. As the rock of the study area is traversed by three set of joints which has broken the rock in to blocks. The intersecting joint set that control the slow movement of water along the joints and attack the rock from all sides result in to formation of concentric shells of rock (Fig.3.14). The volume of fresh rock reduces slowly and the shape of the block becomes more spherical leading to the spheroidal weathering. The rounded boulders formed by this progressive decomposition can be seen in the spot no 1-7. The spheroidal weathering indicate extreme weathering resulting into onion skin like morphology of altered layers enveloping a core of fresh rock

Fig.3.14 Spheroidal Weathering

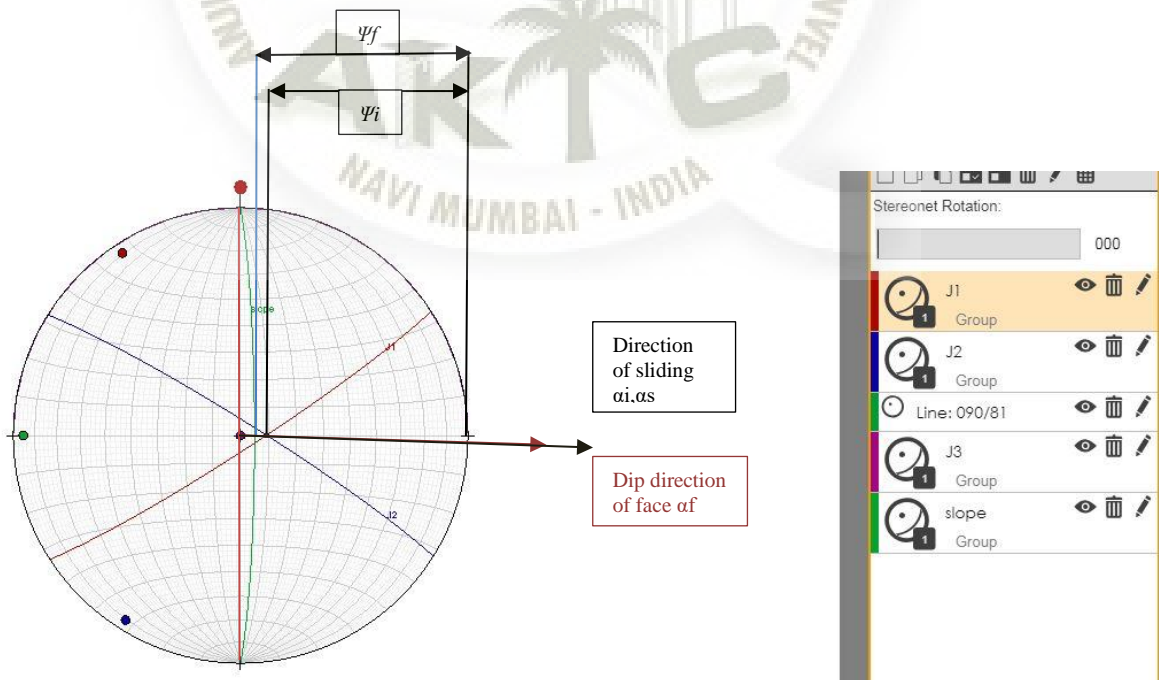
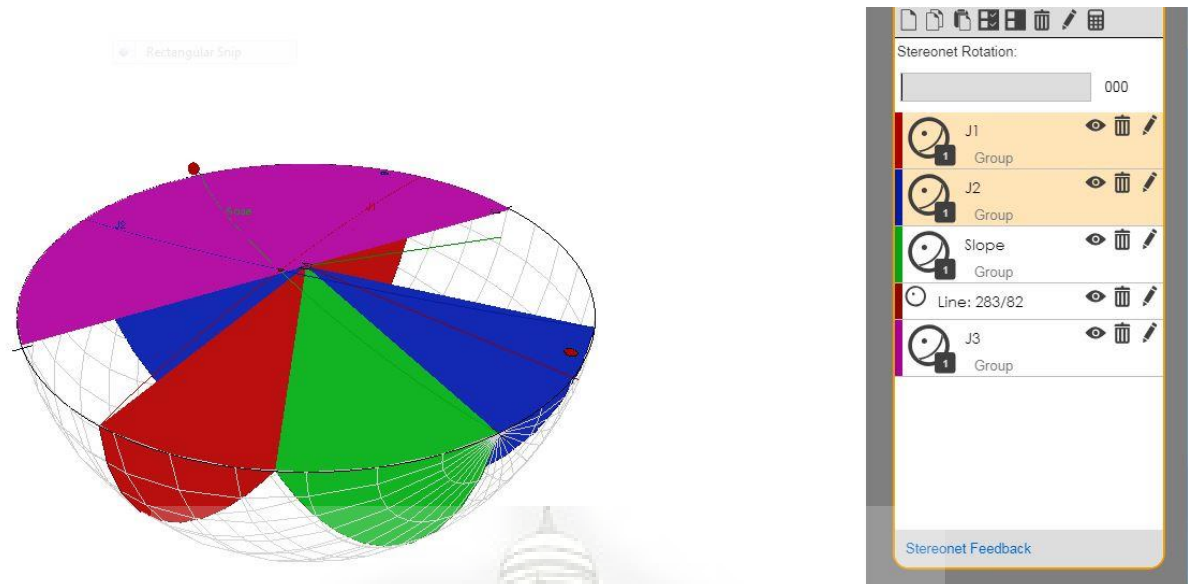
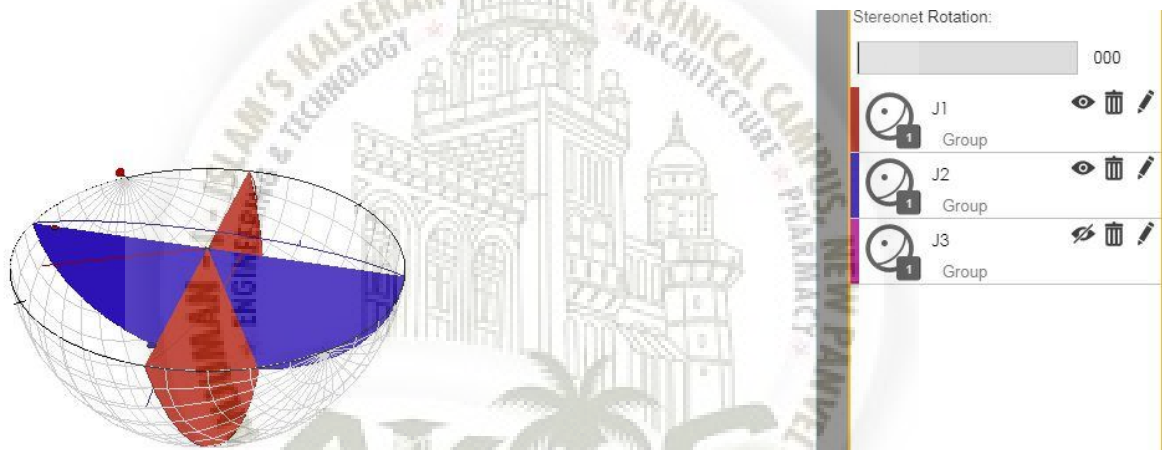
From the ((Fig.3.5(a&b)) rose diagram the orientation of mean J1 (58/85) and J2 (122/85) plane has been taken and plotted on the stereo net. The angle between J1 and J2 is 54° , the intersection line has a trend 90 and plunge 81° (ψ_i) and the dip of slope is 85° (ψ_f) so the joint set J1 and J2 could together form a wedge failure that would slide in the direction of trend. As the slope face is parallel to the direction of sliding and the pole of line of intersection daylights on the face i.e. $\psi_i < \psi_f$ (Fig.3.19a)

Fig.3.19(a) Wedge failure will occur along the line of intersection (dip direction α_i) on slope with dip direction α_f as the of sliding daylight on the slope face

Kinematic analysis of the joints on the left hand side of the road suggest wedge failure as the slope face is parallel to the direction of sliding and the pole of line of intersection daylights on the face i.e. $\psi_i < \psi_f$ (Fig.3.19a) There is more risk of failure at the spots 1-7 and 17-18 as the joint frequency is high at these spots which has led to the formation of highly weathered rock(Fig.3.14). However the rock is solid despite the presence of joints at the spot no 18 to 20 owing to low frequency and less openness of joints in these spots only a thin film of staining is present along the joints and failure will not take as the plunge of line of intersection (82°) is more than the dip of the slope (80°).The kinematic analysis of the joint data from spot no 8-16 show that J1 and J2 are perpendicular to each other and forming a wedge but this slope is stable as the plunge of line of intersection does not daylights on the face i.e. $\psi_i > \psi_f$ (Fig.3.20a). The stability of this face is further strengthen by the fact that very little weathering

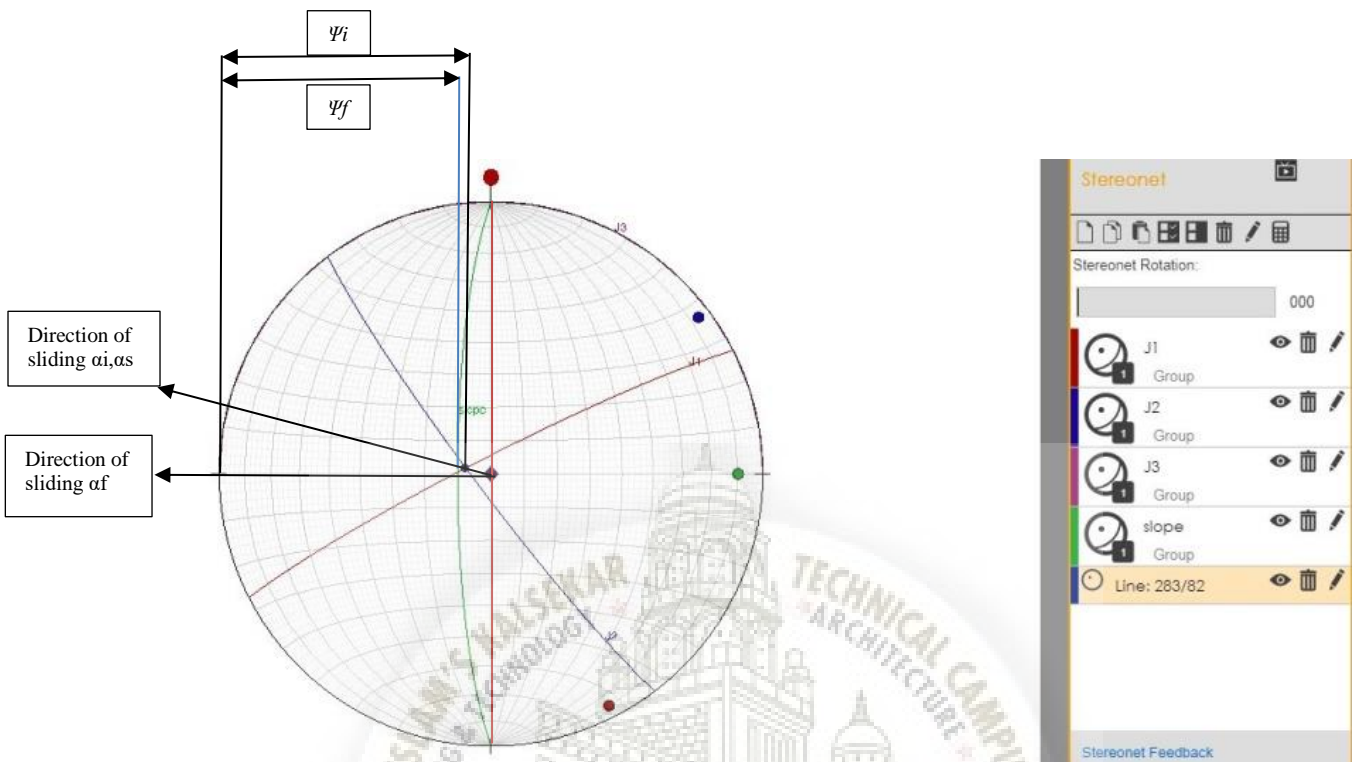
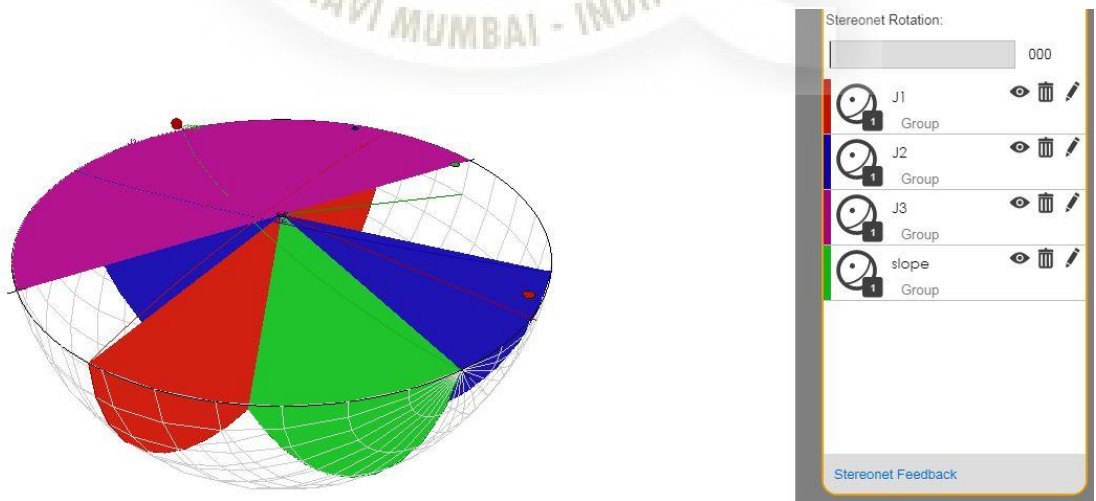
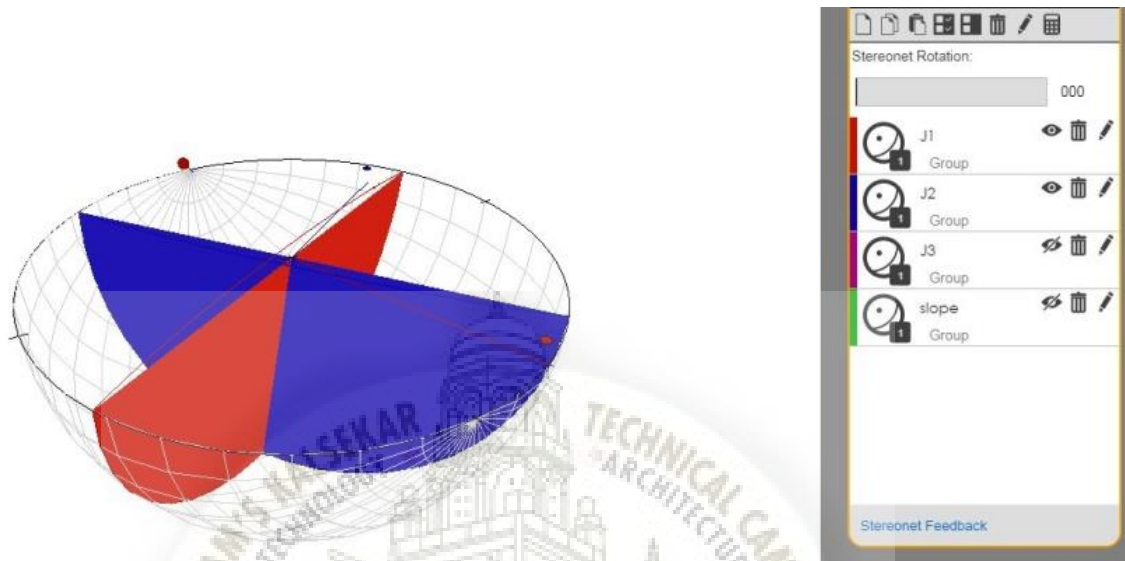
On the left hand side of the road the J1 and J2 are perpendicular to each other and the intersection line has a trend 283 and plunge $82^\circ(\psi_i)$ and the dip of slope is $80^\circ(\psi_f)$ so the joint set J1 and J2 could together form a wedge but it would not fail as the pole of line of intersection does not daylight on the face i.e. $\psi_i > \psi_f$ (Fig.3.20a)

Fig.3.20.(a) Wedge failure will not occur along the line of intersection (dip direction α_i) on slope with dip direction α_f as the direction of sliding does not daylight on the slope face
