A Draft Report

Structural Audit & Health Monitoring of Anjuman-I-Islam's A.A. Khatkhatay English School, Vashi

(29th to 31st December 2017)

Prof. Shafi Mujawar Prof. Dada Patil Prof. Shivaji Sarvade Prof. Suhail Ahmad

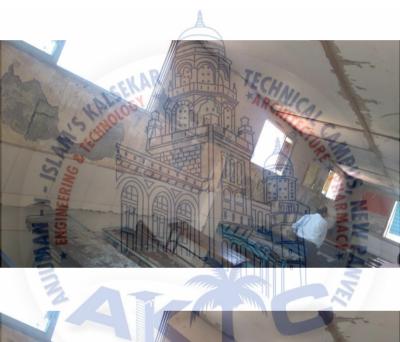
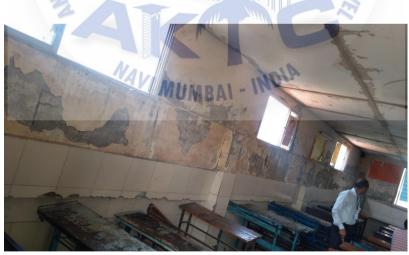
Class VI A

- Tiles on the outer face damaged severely. It needs immediate repair.
- All exposed wall have serious damage to the plaster due to ingress of water.
- Roofing is observed to be improper, need immediate inspection and renewal.
 Roof floor is not suitable for teaching during monsoon.
- All external walls need good quality external plaster and water proofing treatment.

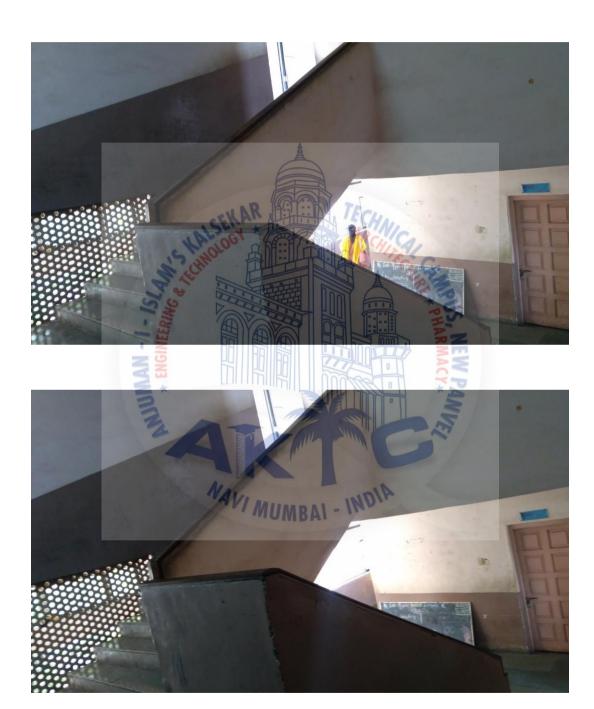
> Staircase

• R C C pardi of staircase need minor repairs.

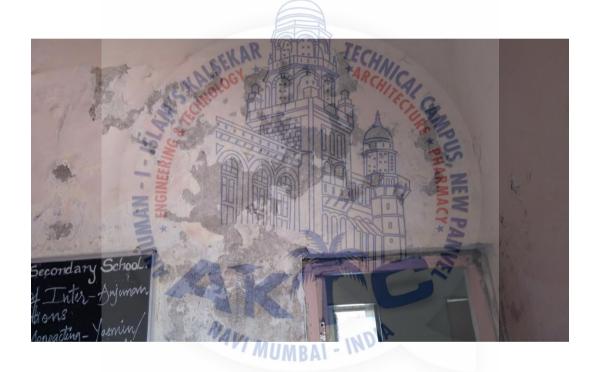
> Class VII A

- Minor cracks at the lintel level.
- Needs proper lintel and sill.
- Wall plaster is damaged severely.
- Exterior wall has minor cracks. Needs repair for on outer face.

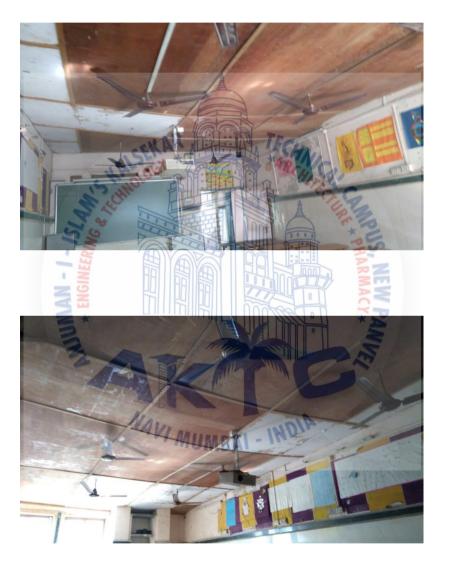
Science Lab

- External walls need good quality plaster and water proofing treatment.
- Rest of the room seems to be in good condition.
- Roofing is improper. Needs proper roofing system.

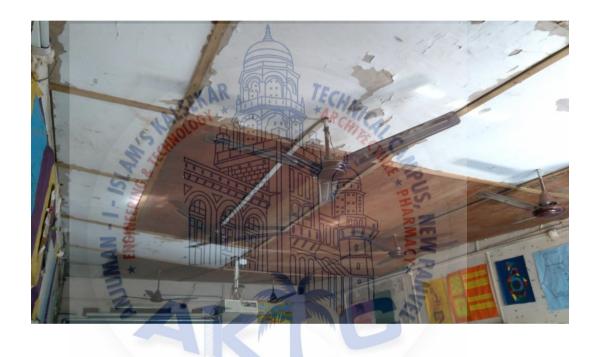
> Class VII B

- Roofing seems to has damaged and need inspection. Improper roofing is allowing ingress of rain water resulting in damage of wall plaster.
- Internal wall plaster is damaged due to ingress of water. Needs good quality external and internal wall plaster with water proofing treatment.

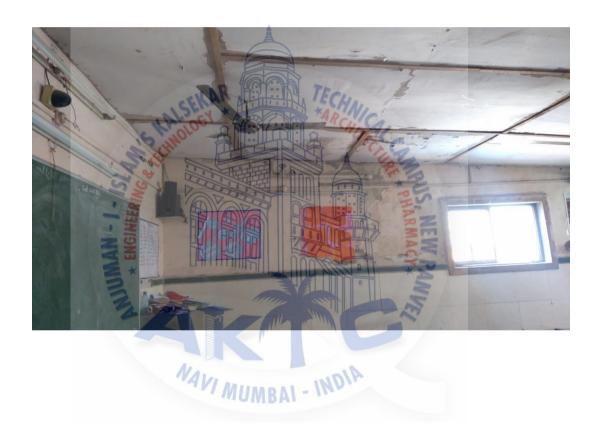
Class V B

- The classroom is adjacent to the water tank.
- The wall plaster is severely damaged due to leakage from the water tank.
- Masonry walls are also under severe distress due to ingress of water from the adjoining water tank.
- Roofing is observed to be improper and damaged. Need inspection and renewal.

- All water tanks of the buildings needs immediate inspection and good quality water proofing treatment.
- Classroom V B is adjacent to one of the water tanks. The room is under severe distress just because of leakage from the water tank. It needs immediate attention, failing to do so will have adverse effect not only on the structure but also on the health of occupants.

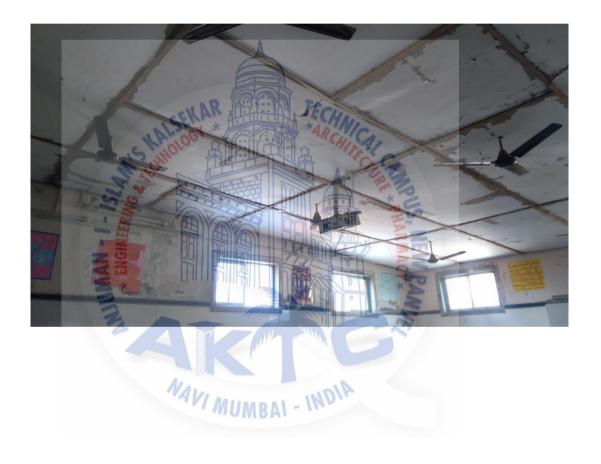
> Class V A

- Plaster is damaged severely due to ingress of rain water from the exposed face.
- All external walls need good quality internal and external plaster with water proofing treatment.
- Roofing is observed to be improper and damaged. Need inspection and renewal.

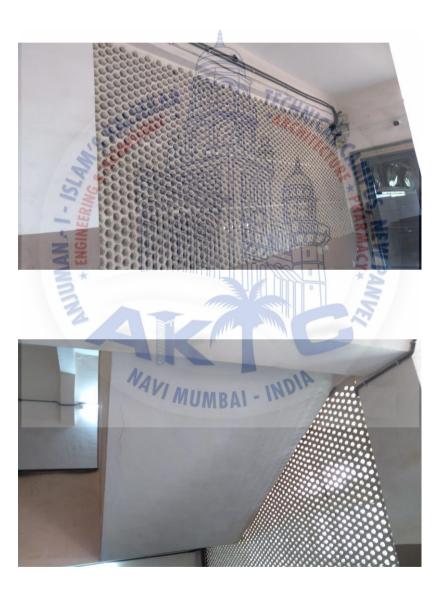
➤ Staircase at 2nd Floor

- Beam supporting the staircase at the second floor has cracks at the bottom.
- Structural load transfer from the secondary beam to the primary beam seem to cause the distress. Needs retrofitting to restore the strength.
- Waist slab of the staircase has cracks. These cracks may lead to corrosion of the reinforcement. It needs immediate repair.

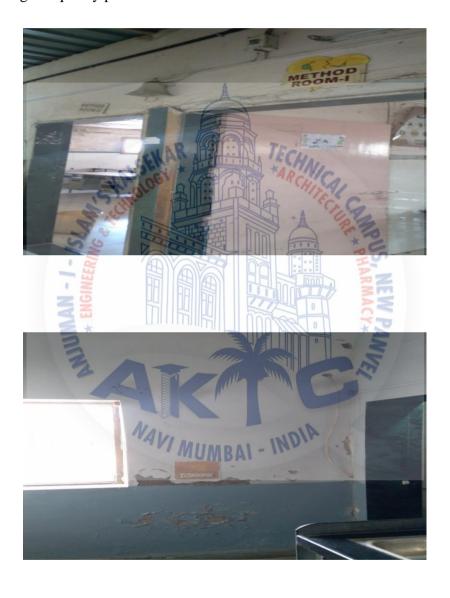
> Method Room-I

- Exterior wall plaster has severe damage due to ingress of rain water.
- The damage is at the primary level, but needs immediate water proofing and good quality plaster.

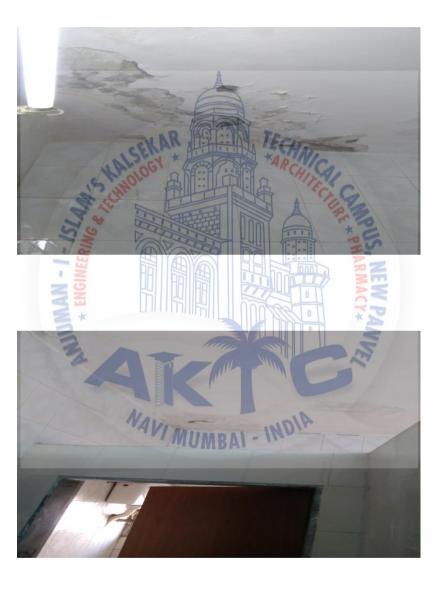
> Sanitary Block adjoining Staff Room

- Sanitary block at the 2nd floor is causing leakages at the first floor block.
- All the plumbing systems of the toilet block at 2nd floor needs to be inspected and good quality water proofing is required for the flooring.

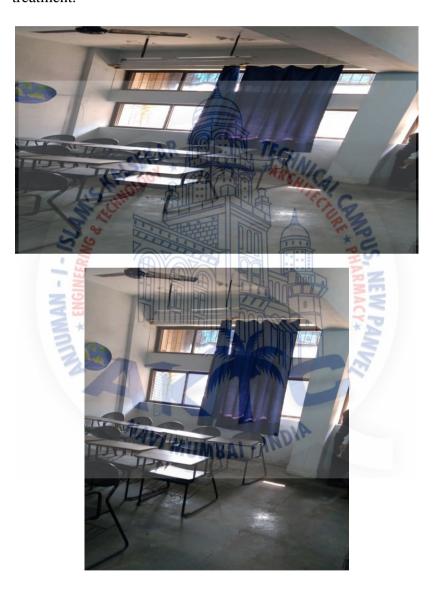
Method Room II

- External column of the room has a major crack. This needs immediate attention.
- Plaster of the room has been damaged due to ingress of water.
- All walls need good quality internal and external plaster with water proofing treatment.

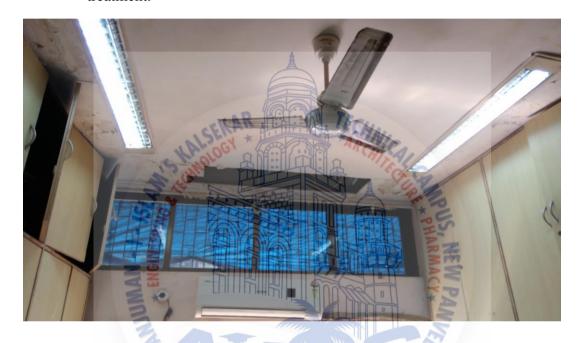
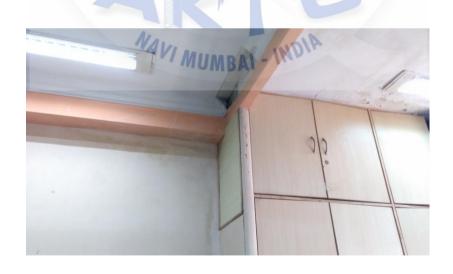
Admin office

- False ceiling (POP) has been severely damaged due to ingress of rainwater and leakages.
- Plaster of the room has been damaged due to ingress of water.
- All walls need good quality internal and external plaster with water proofing treatment.

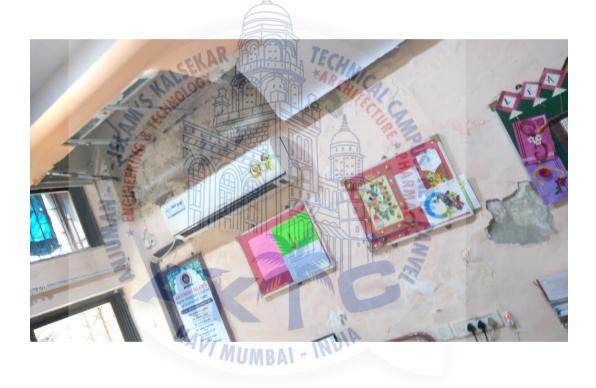
Principal office

- False ceiling (POP) has been severely damaged due to ingress of rainwater and leakages.
- Part of the false ceiling has already collapsed. Extremely dangerous to occupy the room.
- Plaster of the room has been severely damaged due to ingress of water.
- All walls need good quality internal and external plaster with water proofing treatment.

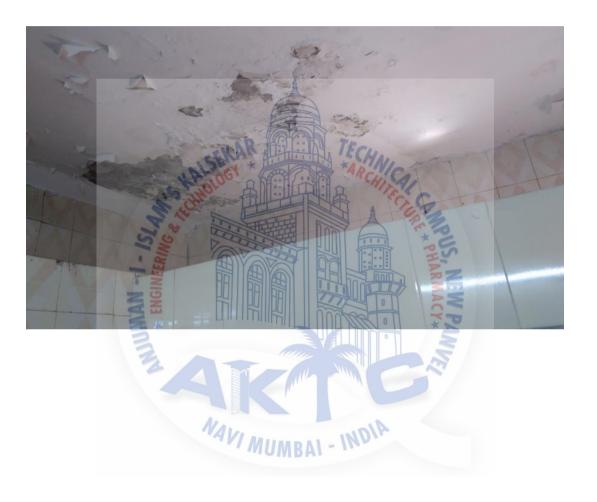
➢ Girl's Toilet

- Girl's toilet adjoin the principal office has leakage from the sanitary block above.
- All walls and floors need water proofing treatment.

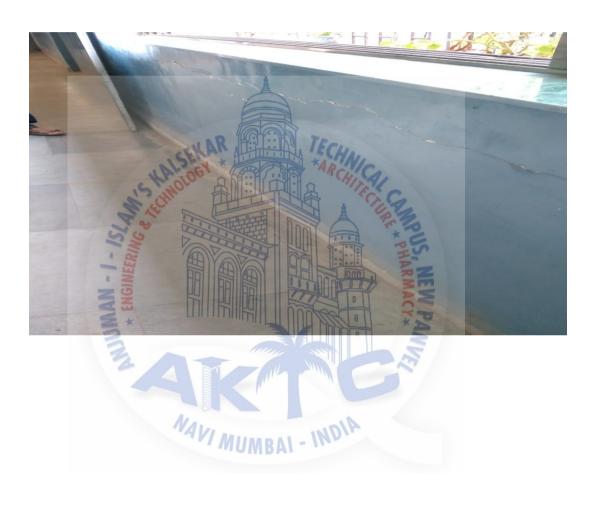
> Passage at First Floor

- Masonry wall at the passage has major cracks and need immediate repairs.
- These cracks form the pathways for the ingress of water which subsequently damage the plaster and strength.

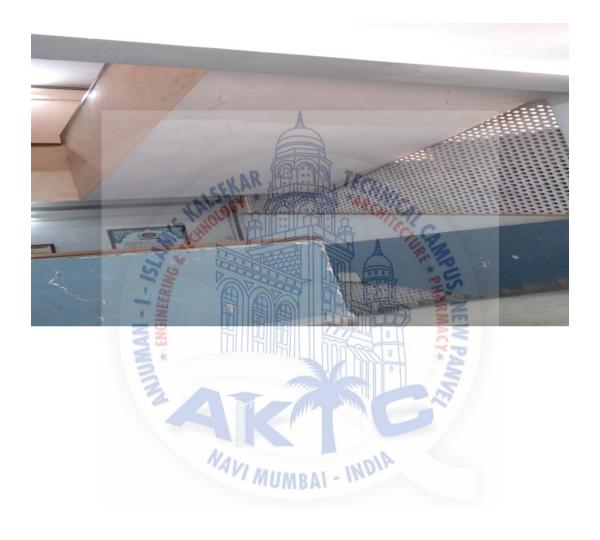
> Staircase at First Floor

• Waist slab of the staircase has cracks. These cracks may lead to corrosion of the reinforcement. It needs immediate repair.

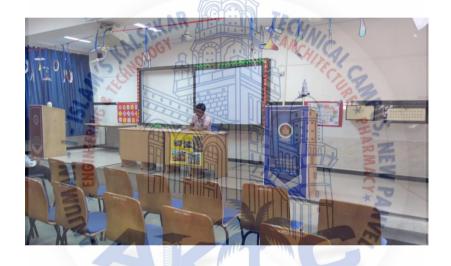
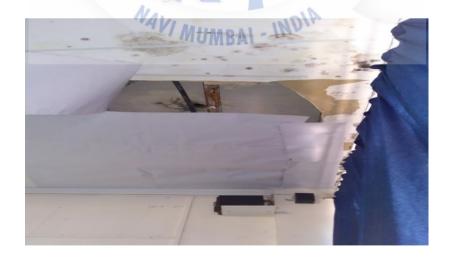
B. Ed. Hall

- All exterior walls have severe damage to the plaster due to ingress of rainwater.
- False ceiling (POP) has been severely damaged due to ingress of rainwater and leakages.
- Sanitary block of the hall is damaged due to leakages from the sanitary block above
- All walls need good quality internal and external plaster with water proofing treatment.

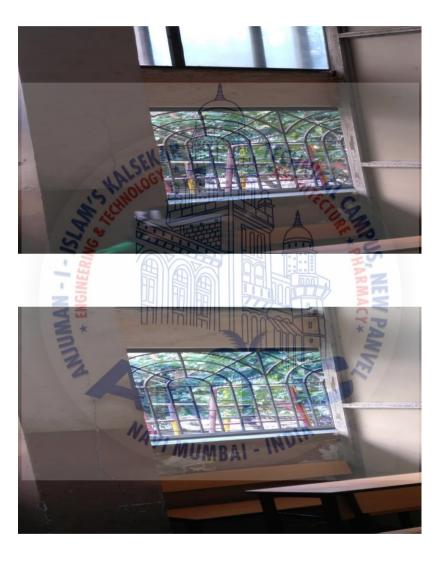
Class Room I B

- All exterior walls have severe damage to the plaster due to ingress of rainwater.
- External column has a crack. Due to reduction of the strength of the column, adjoining beams also have cracks. This needs immediate retrofitting.

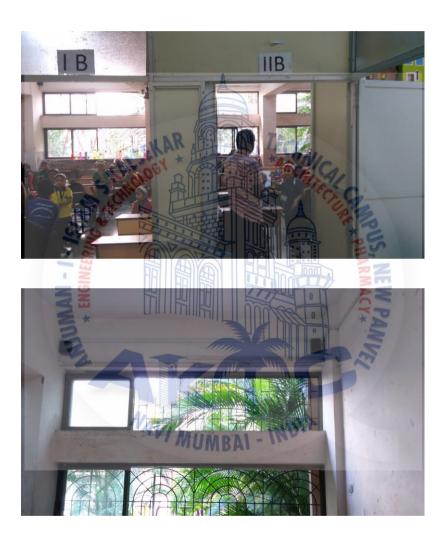
Class Room II B

- All exterior walls have severe damage to the plaster due to ingress of rainwater.
- All walls need good quality internal and external plaster with water proofing treatment.

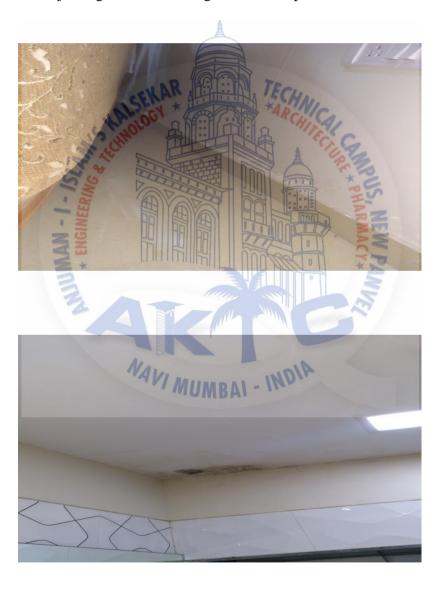
Principal Office (Primary Section)

- Seepage of rainwater for the external wall is observed.
- The leakage from the external wall is leading to the damage of plaster and paints.
- All walls need good quality internal and external plaster with water proofing treatment.
- Adjoining toilet has leakage from the top.

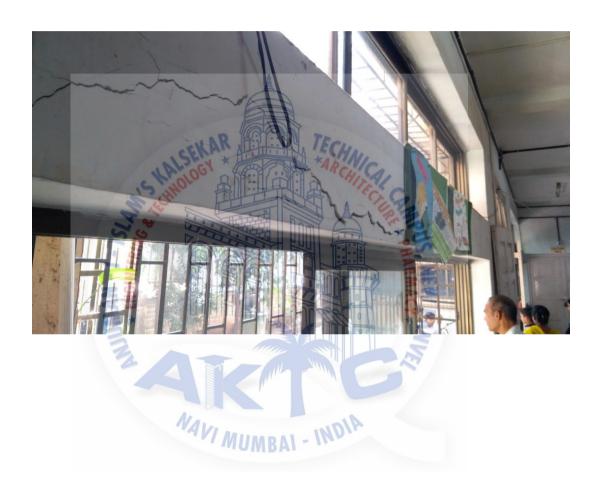
> Passage (Ground Floor)

Beam between the windows at the ground floor has severe cracks. Need immediate attention otherwise the reinforcement will get corroded and loose its strength.

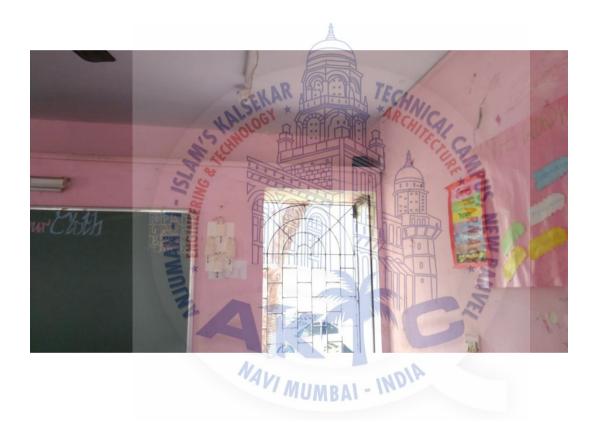
➢ Class Room VIII A

- Minor cracks in the masonry wall are observed.
- All walls need good quality internal and external plaster with water proofing treatment.

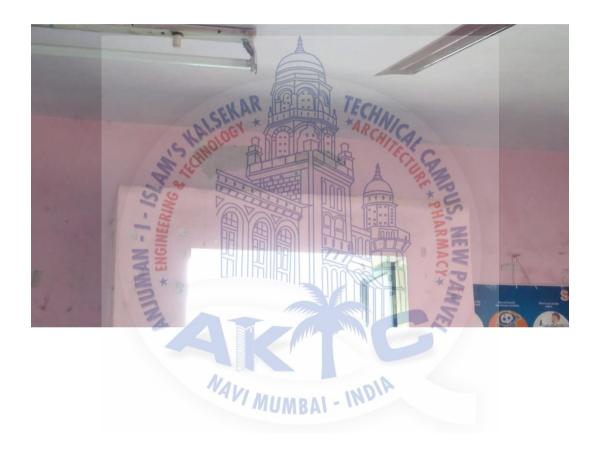
Class Room IX A

- Plaster of the walls damaged due to ingress of water.
- All walls need good quality internal and external plaster with water proofing treatment.

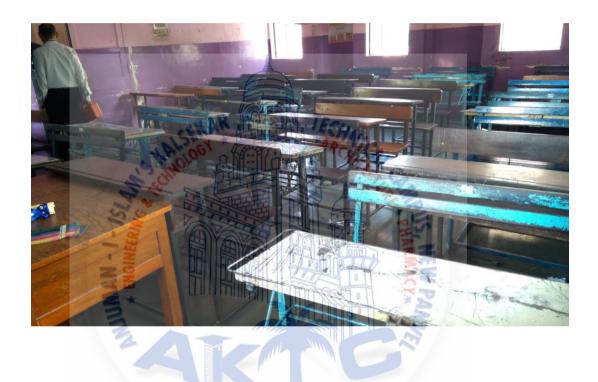
Class Room IX B

- Plaster of the walls damaged due to ingress of water.
- All walls need good quality internal and external plaster with water proofing treatment.
- Overall room is structurally good.

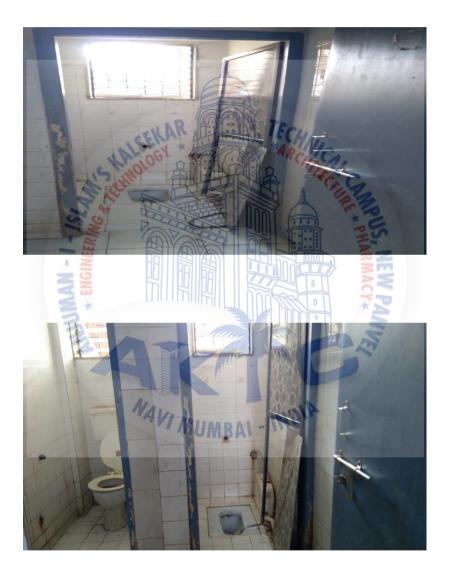
Sanitary Block at First Floor

- Door of the sanitary block needs proper lintel.
- Floor and walls of the sanitary block need immediate water proofing to avoid problems due to leakages in future.

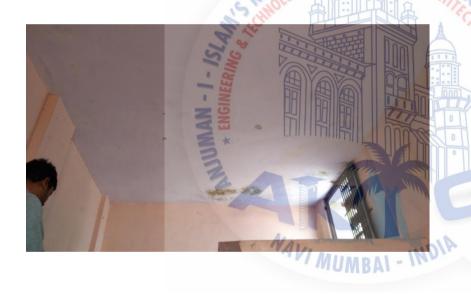
Staircase room and Water Tank above the Staircase Room.

- Roof of the staircase is severely damaged due to leakage from the water tank immediately above the staircase roof.
- The slab appears to be saturated due to leakage from the top.
- The tank needs to be inspected and immediately good quality water proofing is required.
- Water tank leakage is the root cause of most the problems in the structure.
- It is suspected that the previous water treatment work was of extremely poor quality and was carried out with bad workmanship. Entire waterproofing work is of very bad quality and causing severe defects in the structure.

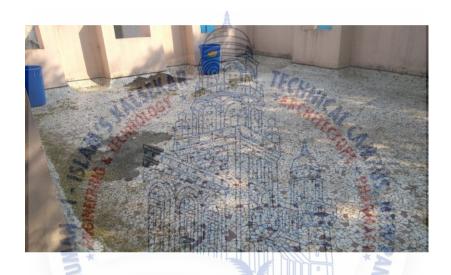
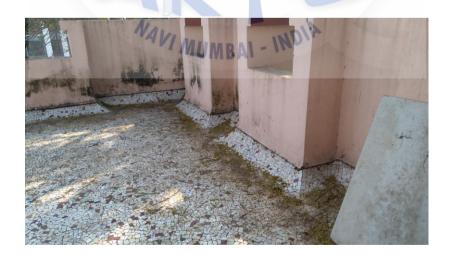
- Waterproofing work done at the terrace is of bad quality and doesn't suffice its purpose.
- Terrace is very poorly maintained. Lots of debris is stored on the terrace and no cleaning observed. This leads to stagnation of water and subsequent seepage to the masonry walls.

- Waterproofing work carried out previously appears to be of very poor quality with a
 bad workmanship. Any further repairs must be supervised by a qualified person and
 must have a quality check.

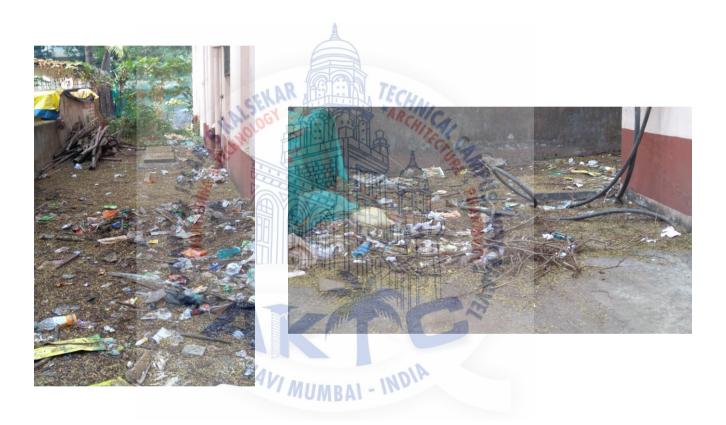
Surrounding of Building B

- Lots of garbage found around the building. It even includes kitchen waste.
- This attracts animals like rats which would weaken the surrounding soil.
- > Surroundings of the building needs to be maintained properly, otherwise it will have adverse effects on the building as well as health of the occupants.

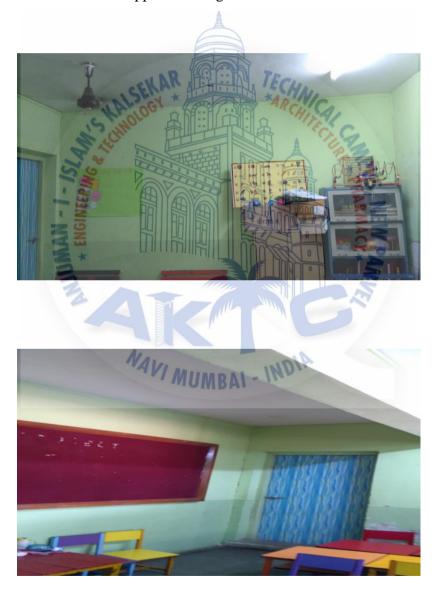
> Nursery

- Partition was done using wall panels in 2012.
- Joint between wall panels and column is improper. Needs to be joined by a proper adhesive.
- Overall room appears to be good.

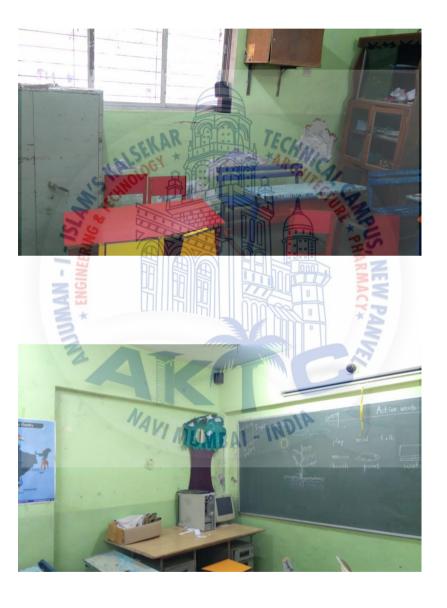
> Junior KG

- Severe leakage in the masonry walls was observed. It is very unfit for the kids to occupy during monsoon.
- All walls need good quality internal and external plaster with water proofing treatment.

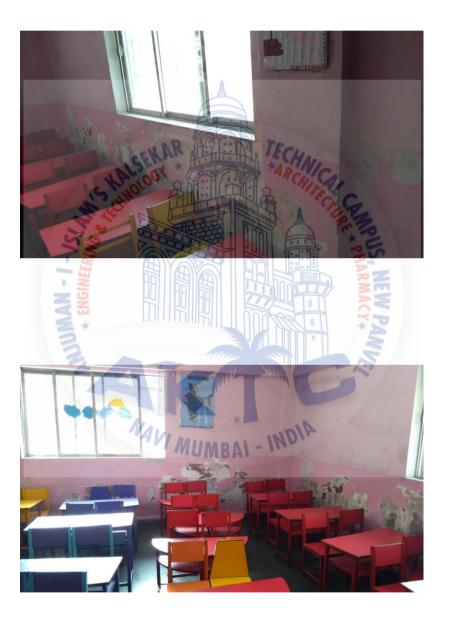
> Senior KG A and B

All walls need good quality internal and external plaster with water proofing treatment.

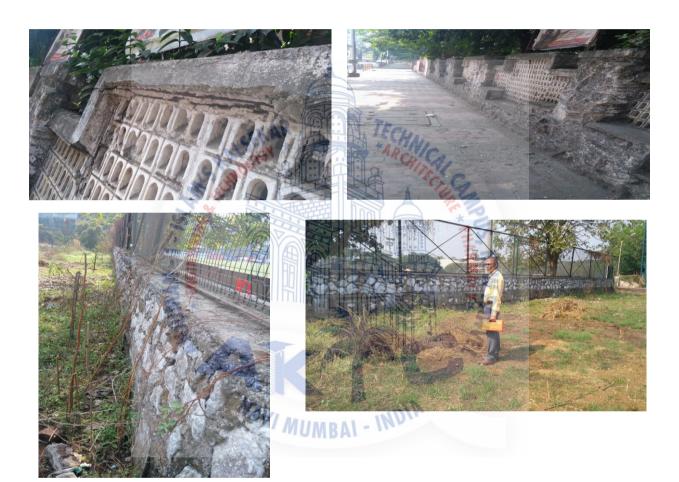
***** Compound wall of the Campus

> Compound wall of the campus is severely damaged and need repair and reconstruction.

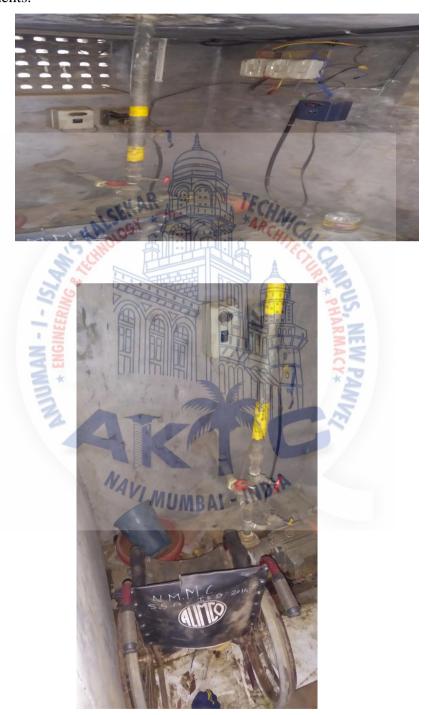
Pump House

> Pump house is in extremely bad condition, needs serious attention to avoid any accidents.
