Structural Health Monitoring by Non Destructive Techniques On Concrete

Submitted in partial fulfilment of the requirements of the degree of Bachelor of Engineering

As per the structural survey carried out on the said buildings, located at Indian Oil Corporation Limited. Indian Oil Nagar, Shivaji Nagar, Chembur – Mankhurd Link Road, Govandi. Mumbai – 400 043. India. , the following points were noted down.

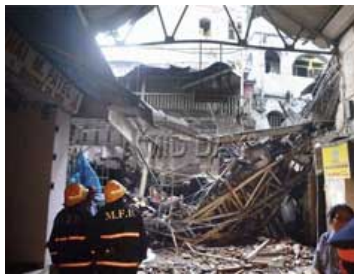
fig 1.1

In recent months there are many such examples for the collapses of different residential as well as industrial structures around Mumbai region. According to NDTV reports Nearly 500 people in Kalbadevi had luck on their side when a portion of a staircase of a chawl in Kalbadevi came crashing down. The staircase of Mani Ben chawl, inside Swadeshi Market, collapsed at around 5 pm on July 24, 2015.

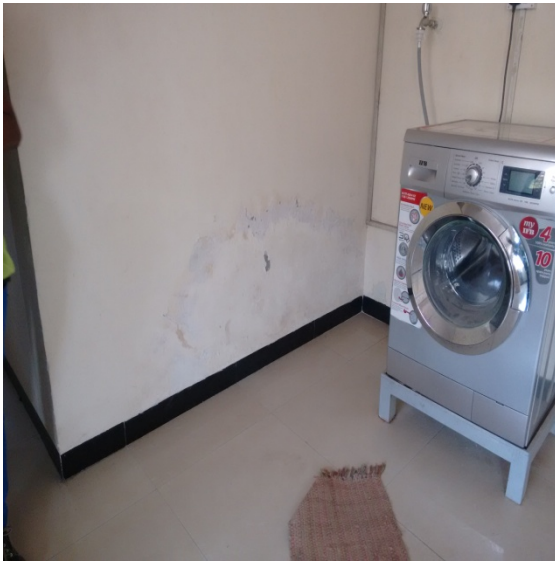
fig 4.1

1. Plaster : The building plaster is in bad condition due to which rusting of reinforcing bar have taken place & there is heavy leakage from the external walls inside the building, which is creating unhygienic conditions for the residents of the building, which may lead to bad health of the residents & is seriously deteriorating the stability of the structure.

Cause: These are surface cracks, this may have taken place due to shrinkage, because of use of rich mortar, sand used is too fine, inadequate curing or lack of bond with background or sulfate attack.

3. **PLASTERING**: It is proposed to remove the existing plaster over the wall & redo the same. Also it is proposed to plaster all the Existing R.C.C member so as to protect them from direct atmospheric deterioration.

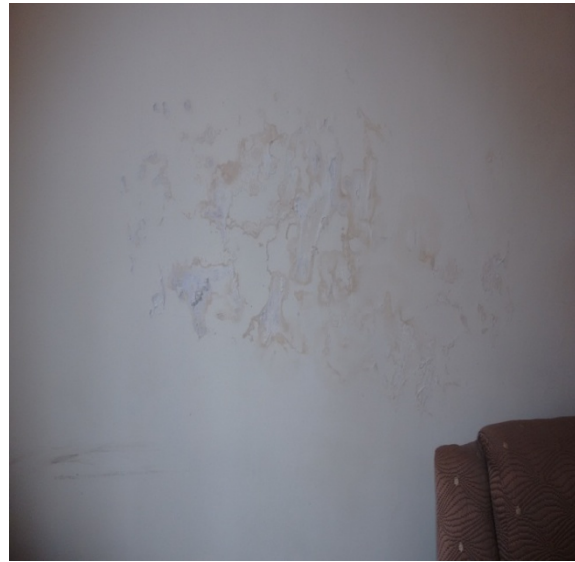
fig 4.2

2. Roof terrace: The water proofing done to the terrace is in bad condition, which is causing leakage in the building below roof terrace.

Cause: Cracks in roof terrace generally result in leakage of rain water through. The main cause of cracking is due to thermal & moisture movements.

4. **WATER PROOFING** : It is proposed to redo the existing waterproofing, wherever applicable so as to avoid any further leakages from the exposed roof slabs.

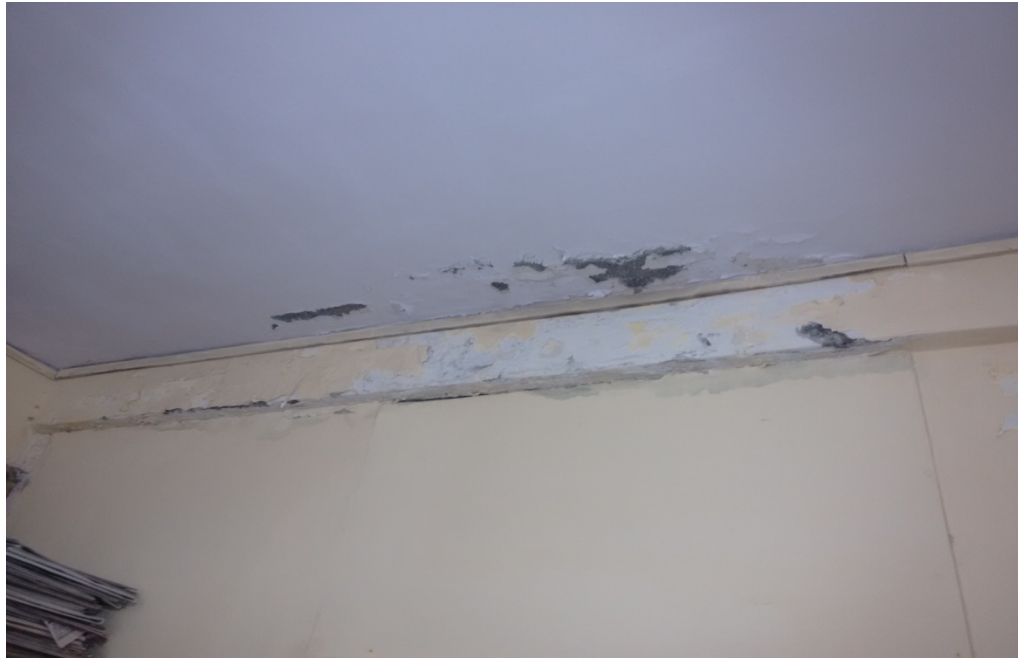
fig 4.3

- a. Vertical cracks in the top of slabs at corners of a building

cause: This is due to shrinkage of R.C.C roof slab on initial drying, as well as thermal contraction, which exerts an inward pull on the walls in both directions. Since near the corners the walls cannot deflect because of interaction of the two walls at right angles to

each other, bending in walls in portion away from corners, has caused vertical cracks about one unit away from the corners.

2. **BRICK WORK** : The brick work in question is in satisfactory condition & it does not require any repairs to it. The minor crack in the walls can be rectified by re-plastering the surface.

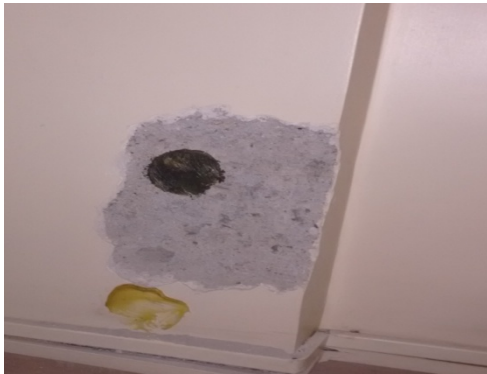
Fig 4.6

f. Vertical cracks at the junction of r.c.c column & masonry :

Cause: These cracks are due to differential strain between R.C.C member & masonry because of elastic deformation, shrinkage & creep in R.C.C column.

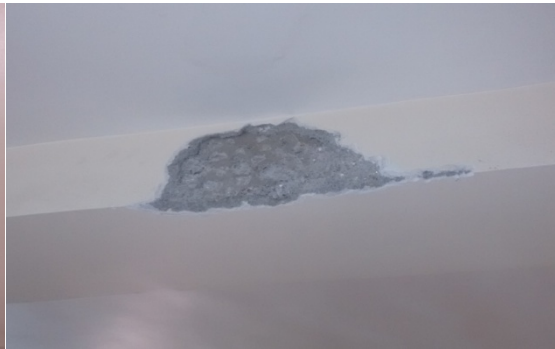
fig 4.7

g. Ripping cracks at the ceiling level in cross walls :

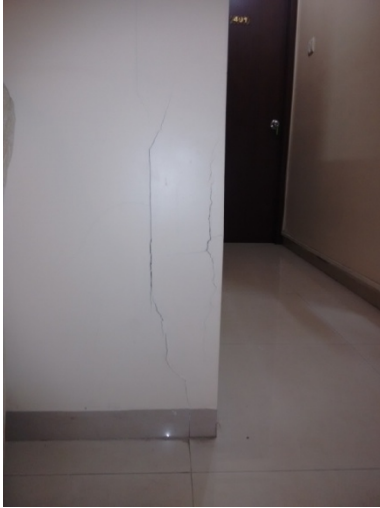
Fig 4.8

i. Horizontal cracks in panel walls :

Cause: These cracks occur if the walls are built too tightly between the beams of RCC frame. These cracks are caused by compressive forces on the wall on account of shortening

of R.C.C due to elastic deformation, shrinkage & creep. These cracks are aggravated by irreversible moisture expansion of brickwork if bricks are used soon after taking out of the kiln.

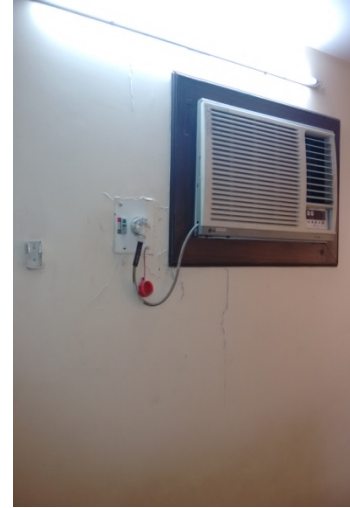
fig 4.10

4. RCC Members : The following points were noted in RCC members.
 - a. Straight cracks in concrete columns, parallel to reinforcement accompanied by spalling of cover and exposure of reinforcement at places in full height of building :
Cause: The cracks are due to corrosion of reinforcement & would occur if concrete in question is not sufficiently dense & moisture from source has been causing continuous dampness in the affected portion.
 - b. Straight cracks in concrete beams at places in all floor parallel to reinforcement accompanied by spalling of cover and exposure of reinforcement at places :
Cause: The cracks are due to corrosion of reinforcement & would occur if concrete in question is not sufficiently dense & moisture from source has been causing continuous dampness in the affected portion.

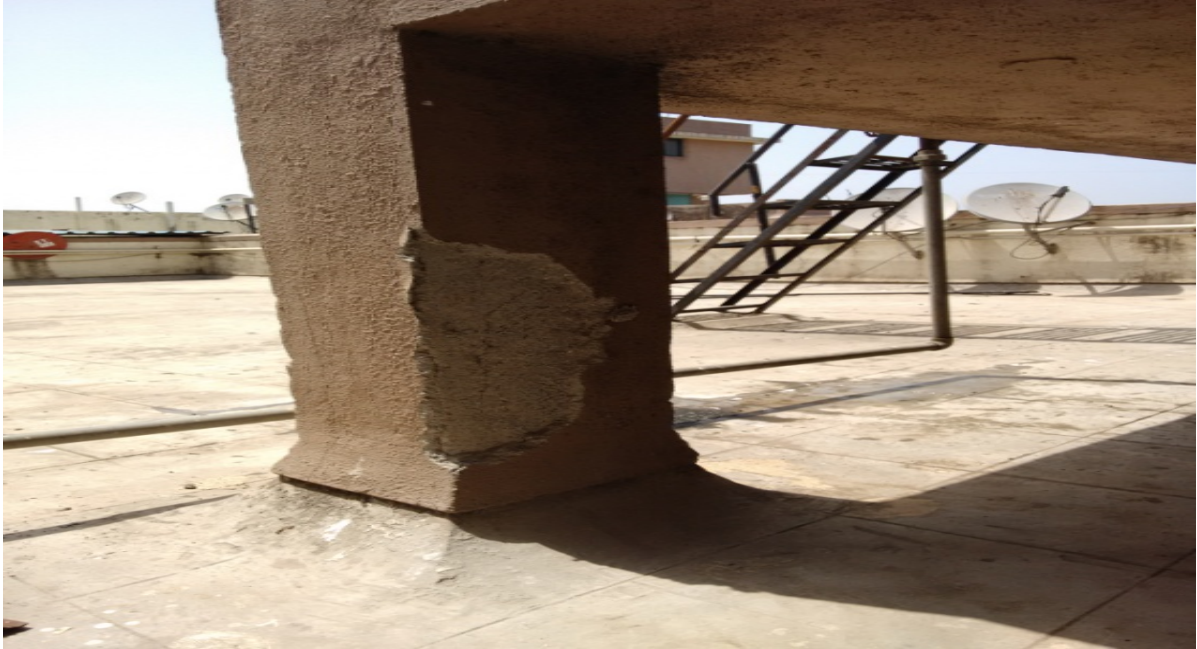
Fig 4.11

5. Rendering or plastering on concrete background :

Cause: These crazing or cracking may occur either due to shrinkage or due to heavy stress in the member. Shrinkage cracks occur if mortar used is too rich or wet, if curing has been inadequate, if sand used is too fine & if rendering/plastering is done long after casting of concrete.

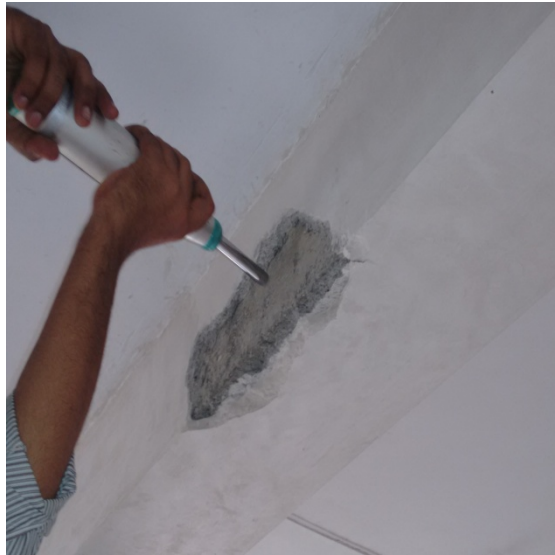
Fig 4.12

reference to the conversion tables, the rebound values can be used to determine the compressive strength.

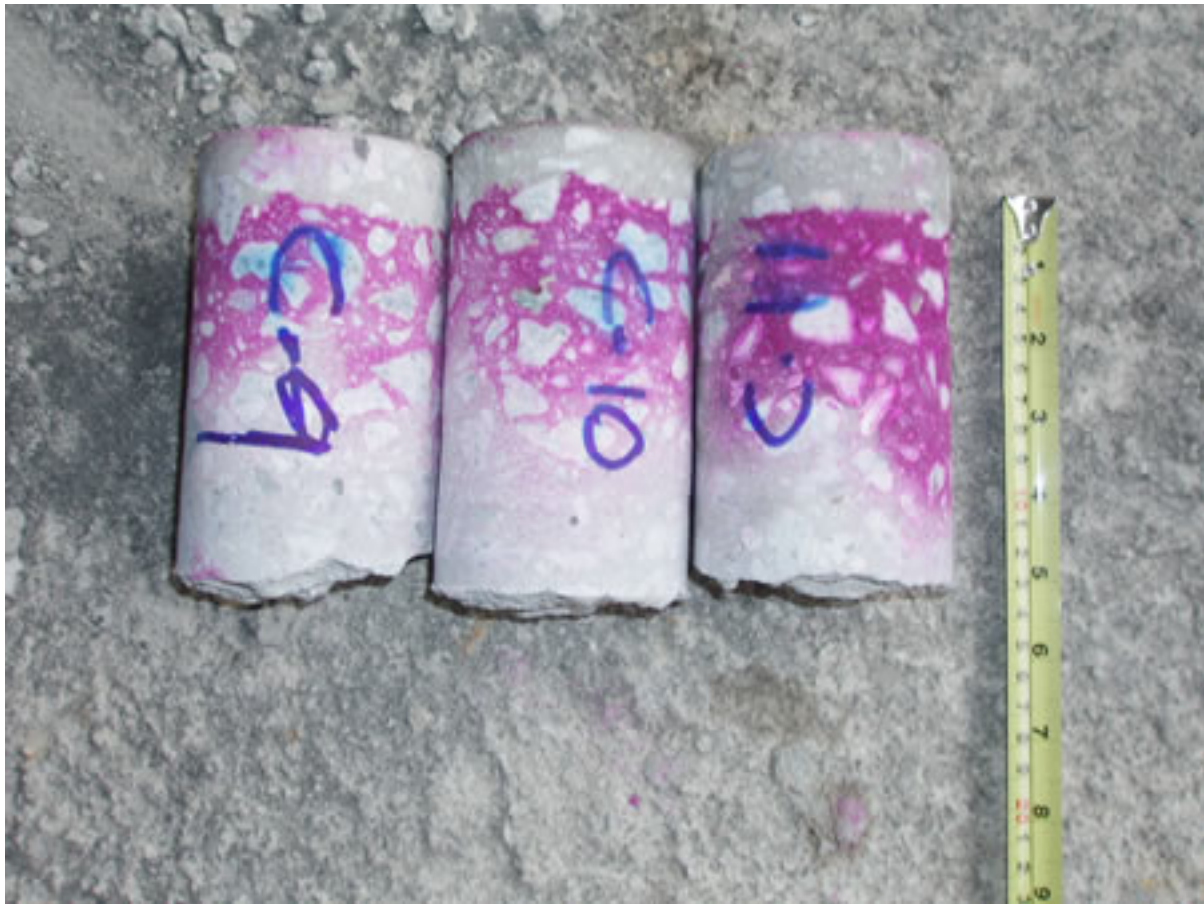
Fig 4.13

Carbonation test on column No “1, 2, 3, 4 & 5” on Ground floor was carried out using phenolphthalein solution which indicated that at different depth & the color was pink. So concluded that the concrete has not been carbonated.

CONCLUSION: The concrete has not been carbonated in the columns in question is satisfactory & is fit for the stability of the structure.
