**A PROJECT REPORT
ON
“FAILURE INVESTIGATION AND REDESIGN OF CRANKSHAFT AND CYLINDER
OF RECIPROCATING PUMP”**

This is to certify that the project entitled “**FAILURE INVESTIGATION AND REDESIGN OF CRANKSHAFT AND CYLINDER OF RECIPROCATING PUMP**”

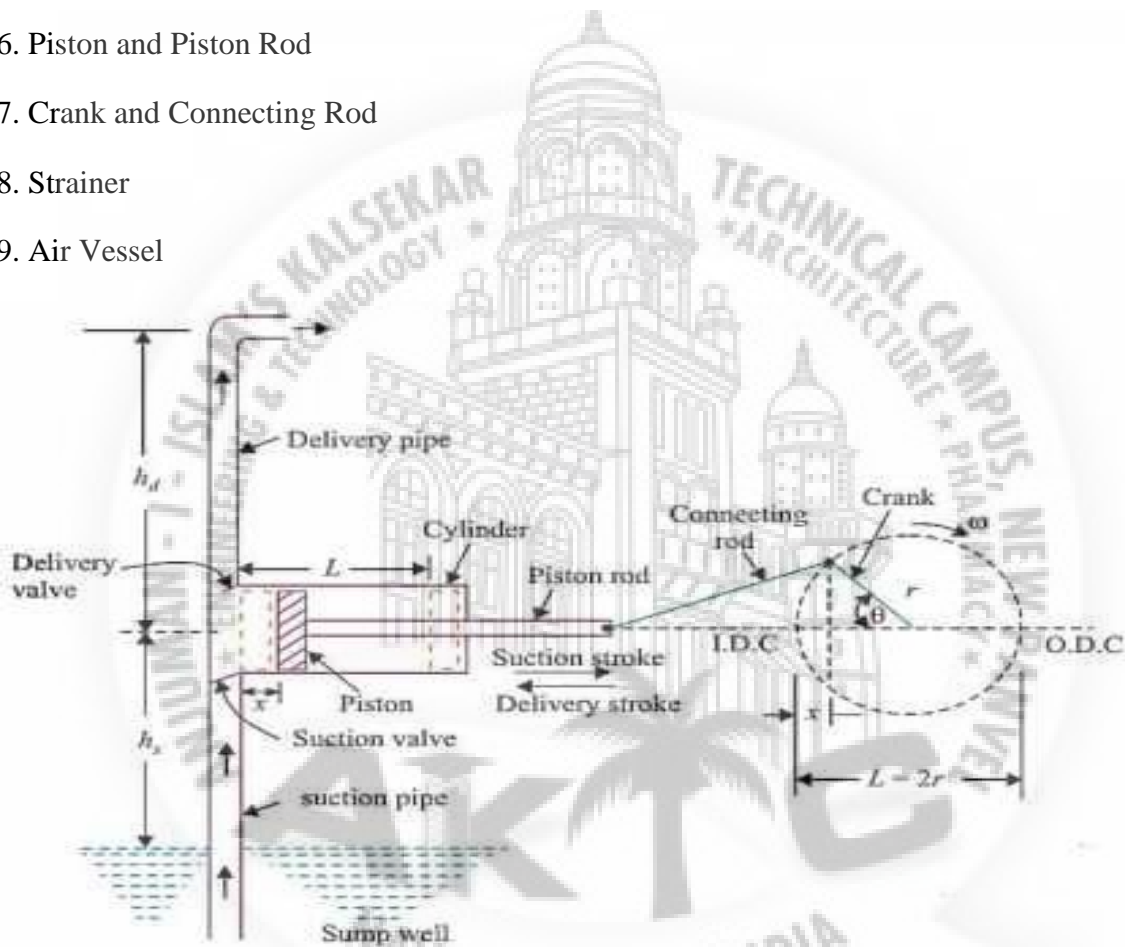
Fig. 1: reciprocating pump

The main components of reciprocating pump are as follows:

1. Suction Pipe
2. Suction Valve
3. Delivery Pipe
4. Delivery Valve
5. Cylinder
6. Piston and Piston Rod
7. Crank and Connecting Rod
8. Strainer
9. Air Vessel

- When the power source is connected to crank, the crank will start rotating and connecting rod also displaced along with crank.
- The piston connected to the connecting rod will move in linear direction. If crank moves outwards then the piston moves towards its right and create vacuum in the cylinder.
- This vacuum causes suction valve to open and liquid from the source is forcibly sucked by the suction pipe into the cylinder.
- When the crank moves inwards or towards the cylinder, the piston will move towards its left and compresses the liquid in the cylinder.

- Now, the pressure makes the delivery valve to open and liquid will discharge through delivery pipe.
- When piston reaches its extreme left position whole liquid present in the cylinder is delivered through delivery valve.
- Then again the crank rotate outwards and piston moves right to create suction and the whole process is repeated.
- Generally the above process can be observed in a single acting reciprocating pump where there is only one delivery stroke per one revolution of crank. But when it comes to double acting reciprocating pump, there will be two delivery strokes per one revolution of crank.

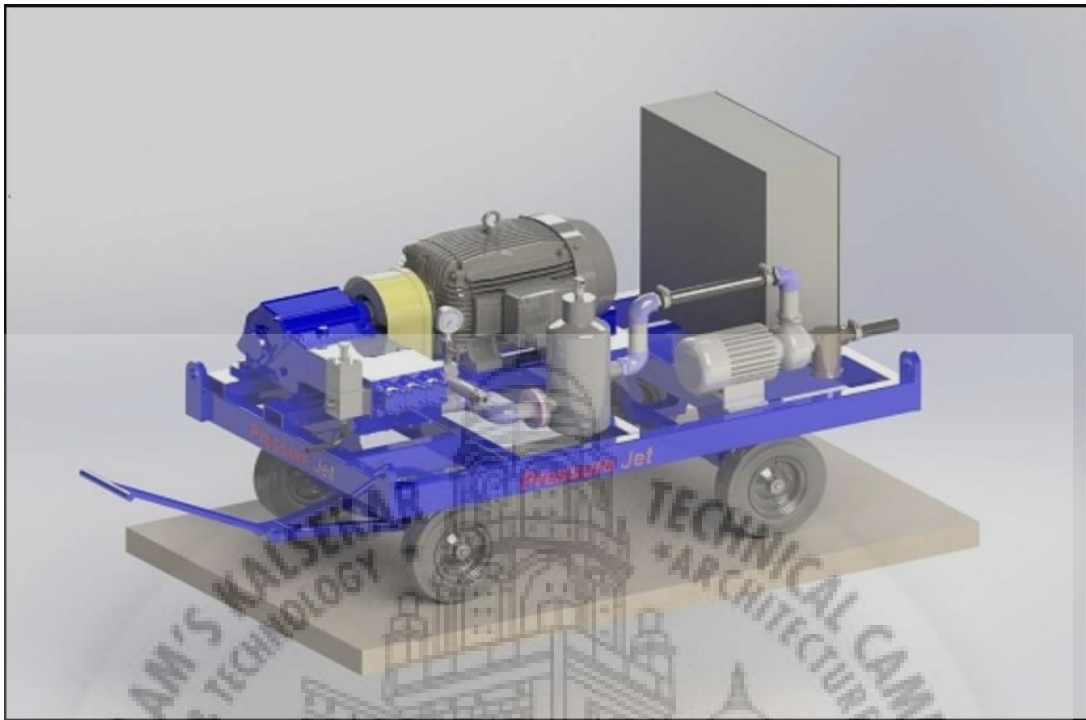
Fig.2: High Pressure Water Jet Cleaning Machine

High pressure waterjet cleaning, commonly known as hydro jet cleaning, is a widespread abrasive water discharge operation. As such, it is very successful because of its powerful blasting effect. In most cases, because of its efficiency, water jet cleaning will require only one operator for a given application.

A highly pressurized and focused stream of water comes from a hydro blasting machine, which includes a pressure pump and the right nozzle.

The pumping unit is the pressure generator used to force out the carrier fluid at high velocity. Plunger-type high pressure cleaners pumps are commonly used to generate high pressure water for water jet cleaning and wet or water abrasive blasting for non-abrasive pressure cleaners or rinsing. Crankshaft driven plunger pumps are commonly used for pressure generation. Crankshaft driven plunger pumps may be more efficient in electrical energy costs compared to intensifiers.

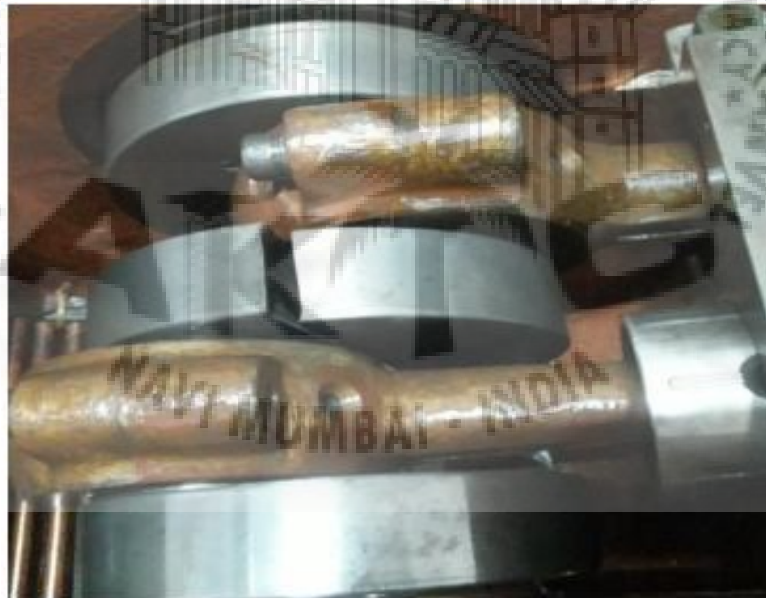
Fig. 3: Failure pattern of crankshaft

. Then reciprocating pump increases the pressure of water up to 25000 psi. But required pressure is 15000 to 20000 psi so pressure is controlled by bypass valve. Company provide their machine to some companies like company consists of boiler, sugar mill etc. For cleaning purpose.

The capacity of machine is 25000 psi and the failure of crankshaft and cylinder is occurring at the pressure 15000 to 20000psi. The frequency of failure is high these failures occurs sometimes in one week or sometimes in one month. Because of these failures company facing one more problem that is the material and manufacturing cost of the components are very high.

- It is conclude that the crankshaft design was not applicable for the pressure 25000 psi which is failing due to bending stress.
- so we calculated the bending stress induced at the failure section. Which is exceeding the safe stress.
- so we have increased the thickness of crank web and find the bending stress for that thickness and we found that stress was inducing less than the safe stress.
- As we increase the thickness of crank web the bending stress induced in it reduces.

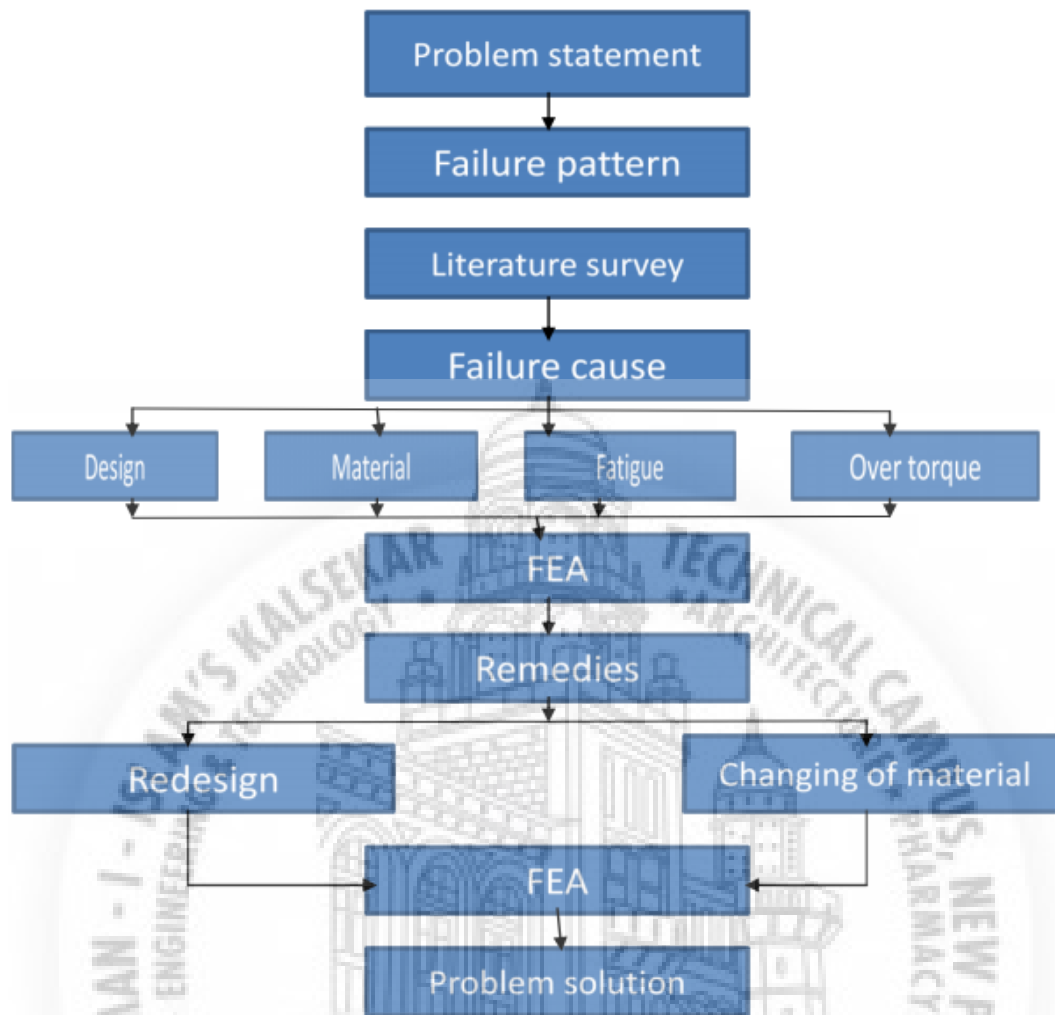
Fig. 5: Methodology flow chart

- To solve our problem we will follow this flow chart. The first element is problem statement which has been discussed previously. Then second is failure pattern, we have seen some failure pattern.

- Third is literature survey, we did some literature survey discussed previously, in which authors have shown some failure pattern, we will compare those failure pattern to our pattern.

- Then we will find some failure causes like improper design, improper material selection or defect in chemical properties of material, fatigue failure and over torque.

- By considering these all parameters we will find out the forces and torque acting on crankshaft and cylinder. Then we will analyse old design in FEA software.

- Then we will find remedies to our problem, according to that we will redesign our component or change the material, then analyse our new design in FEA software like that we will get solution.

- Then we will create 3d model of new design and give it to company so that they can manufacture the crankshaft according to new design.

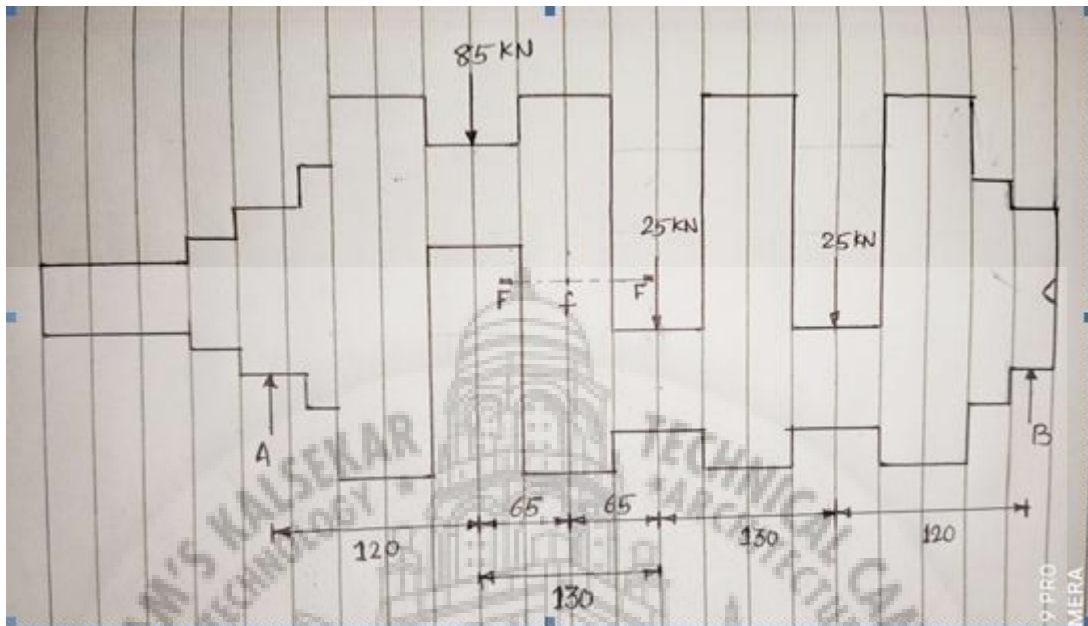
Fig. 6: Crankshaft

Material of crankshaft:

- MSEN8

Yield stress = 290mpa

Calculating reaction force at bearing:

Calculating bending moment at failure section:

$$\text{bending stress} = 100 \text{ mpa}$$

bending stress calculated > bending stress design

hence design is failed.

If we increase the thickness from 50mm to 52mm then bending stress is,

$$\text{bending stress} = 92.99 \text{ mpa}$$

hence design is safe.

- Safe bending stress = 94.25mpa
- Thickness of crank web (old design) = 50mm
- Bending stress induced in crank web for 50mm thickness = 100mpa
- Calculated bending stress > safe bending stress hence design failed.
- Thickness of crank web (new design) = 52mm
- Bending stress induced in crank web for 52mm thickness = 92.99mpa
- Calculated bending stress < safe bending stress hence design is safe.
