GEOLOGICAL INVESTIGATION & LANDSLIDE RISK ASSESSMENT OF A SECTION NEAR KHARPADA VILLAGE ALONG MUMBAI-GOIA HIGHWAY

Submitted in partial fulfilment of the requirements

Bachelor of Engineering

Anjuman-I-slam's Kalsekar Technical Campus

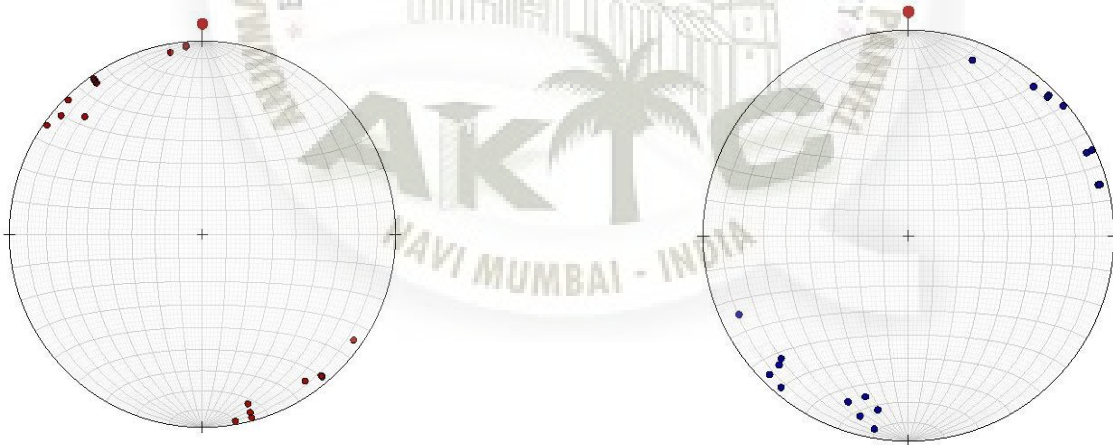
The pole diagram of this set of joints is showing two clusters on opposite quadrants as some joints dip steeply NW and some steeply SE(Fig. 3.4a). The second set of joint is also steeply dipping (70° - 88°) with a strike NW-SE.

The pole diagram of this set of joints is also showing two clusters on opposite quadrants as some joints dip steeply NE and some steeply SW (Fig. 3.4b). The third set of joints is horizontal striking N-S. These joints have developed only in the upper part of the formation and may be the result of unloading.

Fig. 3.4.(a) Pole diagram for joint set J1

Fig. 3.4.(b) Pole diagram for joint set J2

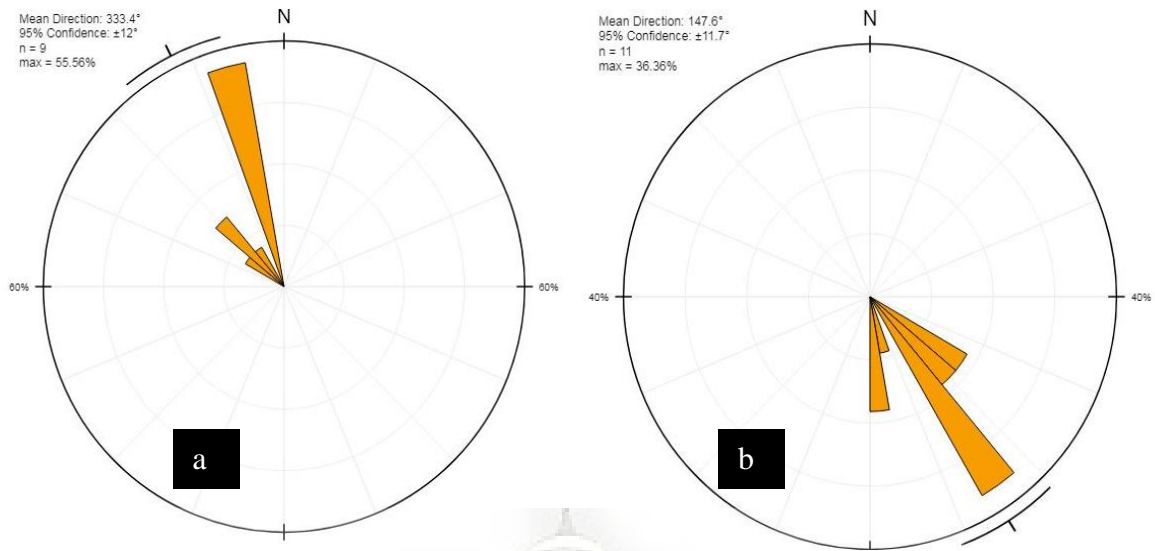
Fig.3.5 Rose Diagram for joint set J1 showing two oppositely dipping planes

From the ((Fig.3.5(a&b)) rose diagram the orientation of mean J1 (58/85) and J2 (122/85) plane has been taken and plotted on the stereo net. The angle between J1 and J2 is 54° , the intersection line has a trend 90 and plunge 81° (ψ_i) and the dip of slope is 85° (ψ_f) so the joint set J1 and J2 could together form a wedge failure that would slide in the direction of trend. As the slope face is parallel to the direction of sliding and the pole of line of intersection daylights on the face i.e. $\psi_i < \psi_f$ (Fig.3.19a)

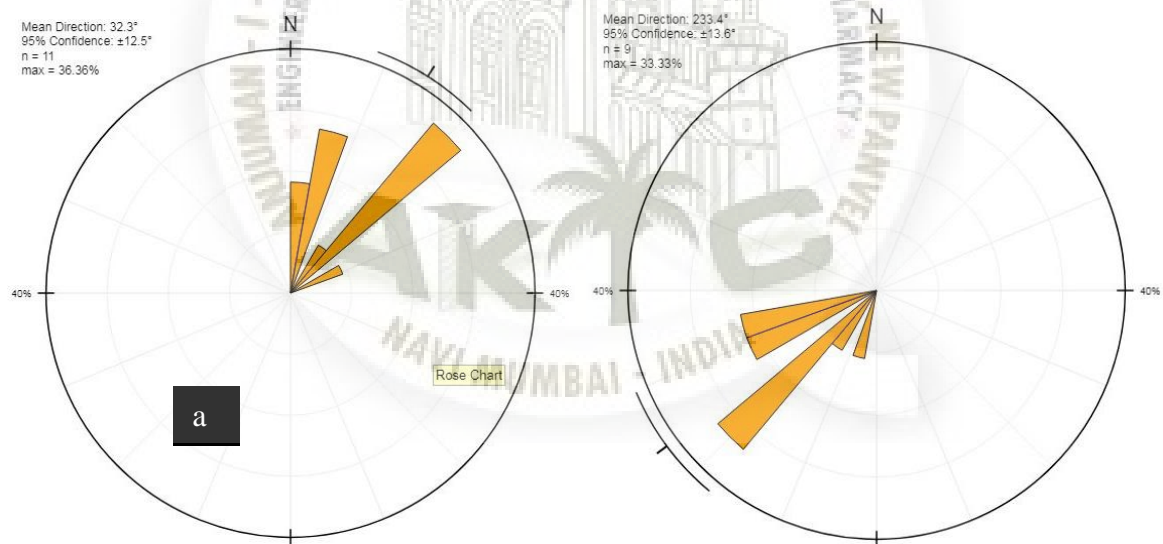
Fig. 3.6 Rose Diagram for joint set J2 showing two oppositely dipping planes
