# **STRUCTURAL AUDIT & HEALTH MONITORING OF A RESIDENTIAL R.C.C. BUILDING**

# STRUCTURAL AUDIT OF (G+2) BUILDING AT PANVEL

Khan Plaza, Patel Mohalla Opp. Indi Doctor Old Panvel, Navi Mumbai.  
The building is RC structure which contains Ground+2 upper stories.  
The building was constructed 25 years back.

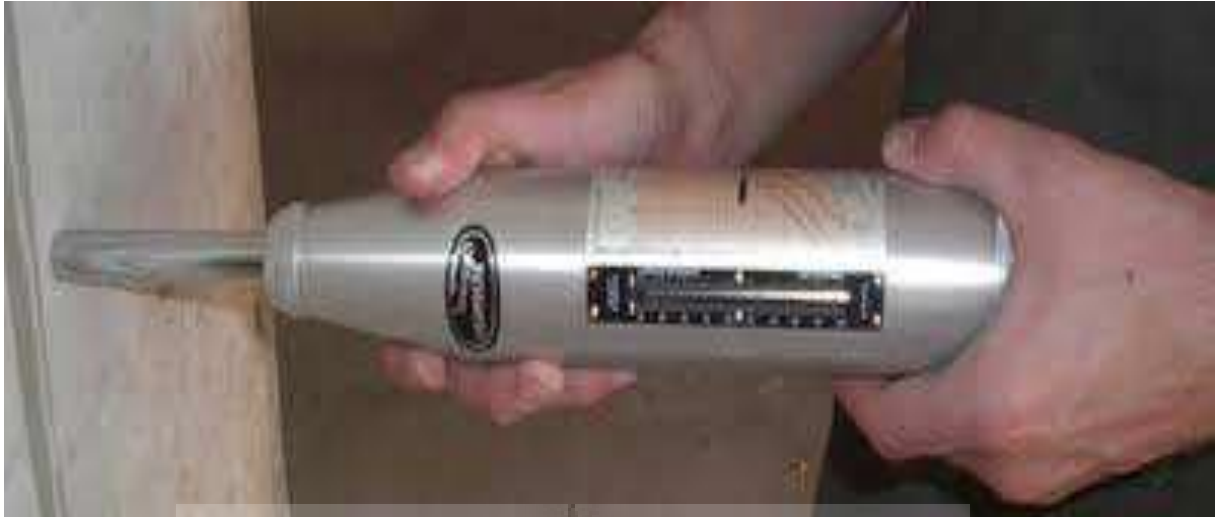
fig no. 1.1 Schmidt's Hammer

The operation of Rebound Hammer (also called Schmidt's Hammer) is illustrated in fig below when the plunger of rebound hammer is pressed against the surface of concrete, a spring controlled mass with a constant energy is made to hit concrete surface to rebound back. The extent of rebound, which is a measure of surface hardness, is measured on a graduated scale. This measured value is designated as Rebound Number (a rebound index). A concrete with low strength and low stiffness will absorb more energy to yield in a lower rebound value.

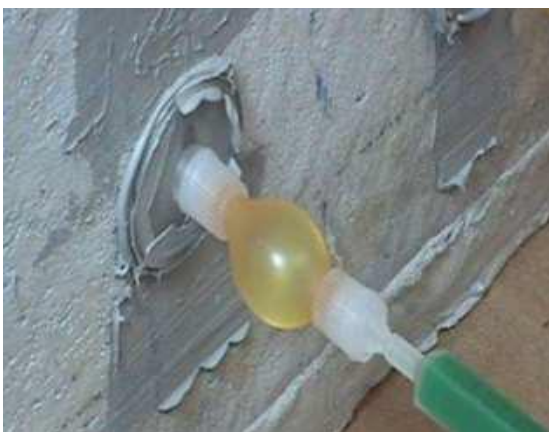
fig no. 2.2 Epoxy treatment

Cracks as narrow as 0.002 in.(0.05 mm) can be bonded by the injection of epoxy. The technique generally consists of establishing entry and venting ports at close intervals along the cracks, sealing the crack on exposed surfaces, and injecting the epoxy under pressure. Epoxy injection has been successfully used in the repair of cracks in buildings, bridges, dams, and other types of concrete structures (ACI 503R). However, unless the cause of the cracking has been corrected, it will probably recur near the original crack. If the cause of the cracks cannot be removed, then two options are available.

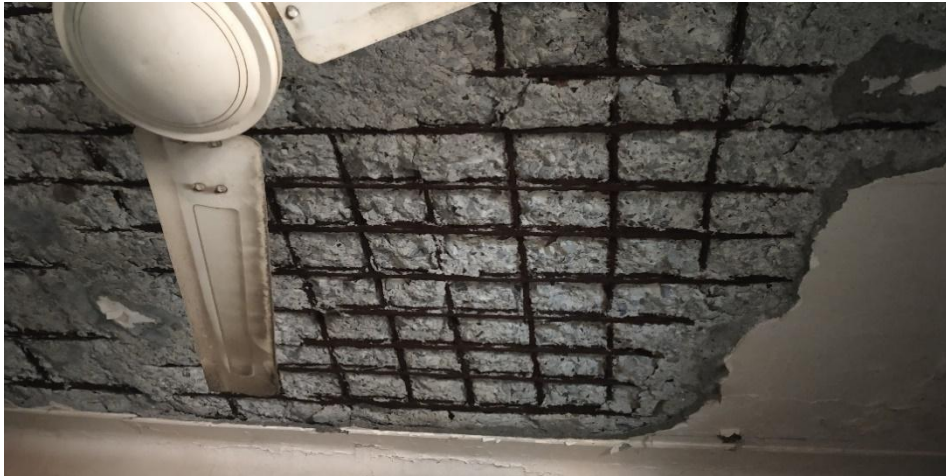
**fig no. 5.2 Slab of B-2, Hall**

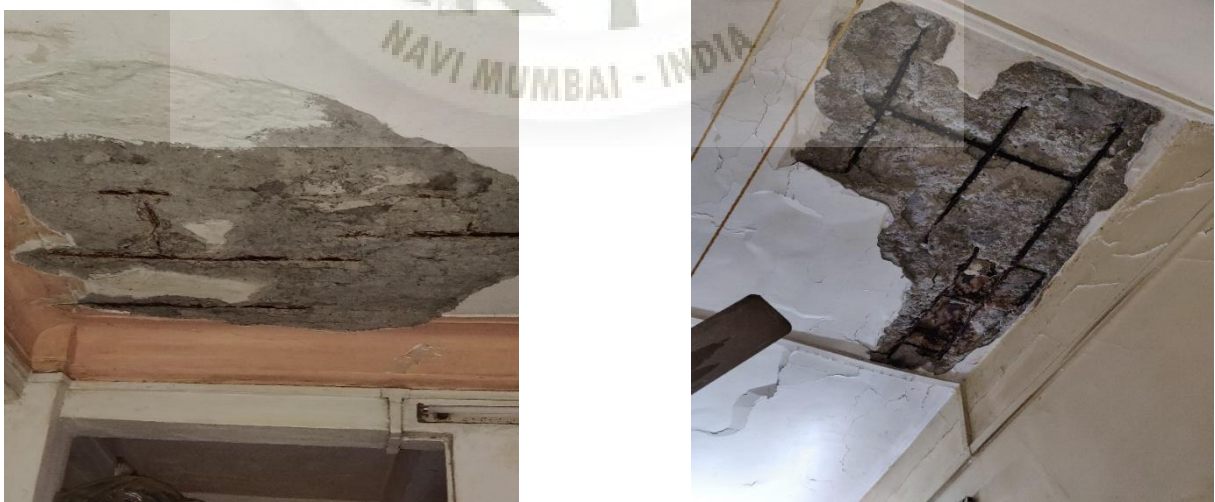
fig no. 5.5 deterioration of plaster

Removing the deteriorated surface plaster followed by replastering using cement, sand mortar of ratio 1:3 is suggested. Proper curing to be done till the surface attains adequate toughness.

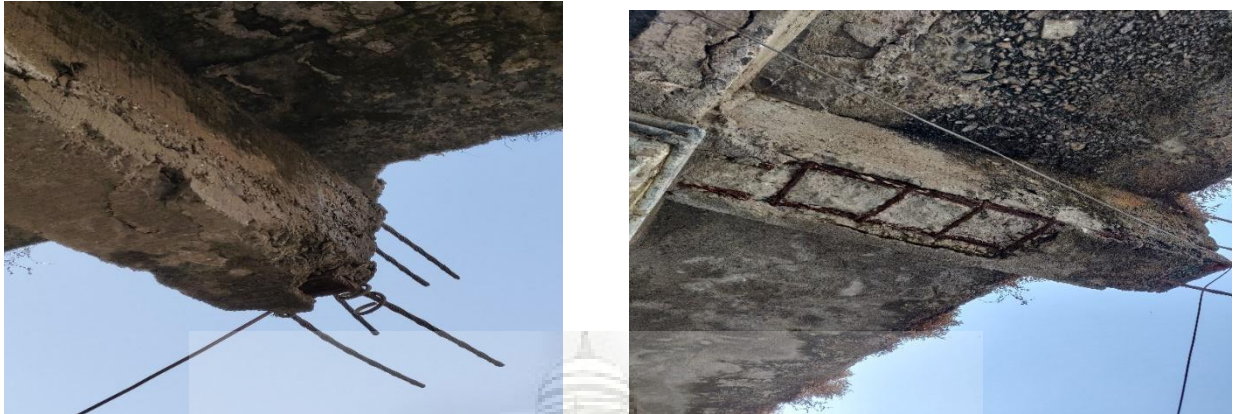
**fig no. 5.6 Beams open to atmosphere with visible reinforcement**

In case grout is used for filling the forms, it is allowed to settle for about 20 minutes after full filling and then is refilled to overflowing condition. The top of the jacket must be finished with pneumatically projected or hand placed concrete
